**MILLPORT TOWN HALL  
REPAIRS AND CONVERSION TO  
COMMUNITY FACILITY**

**FEASIBILITY COSTS  
FOR**

**BUILDING INSPECTION REPORT**

13277 - Structural Inspection at Millport Town Hall, Millport

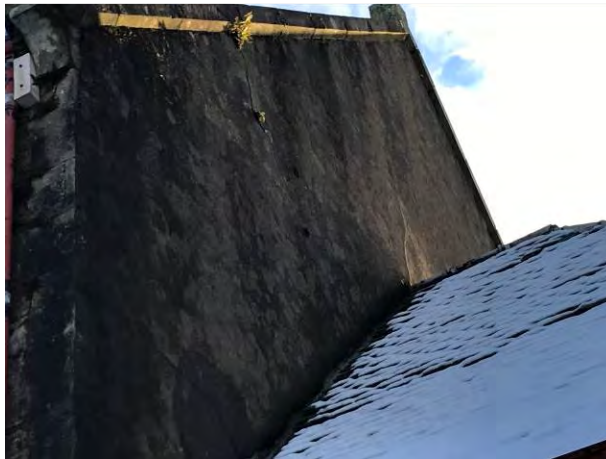
Photo 3. Cracking to high level render

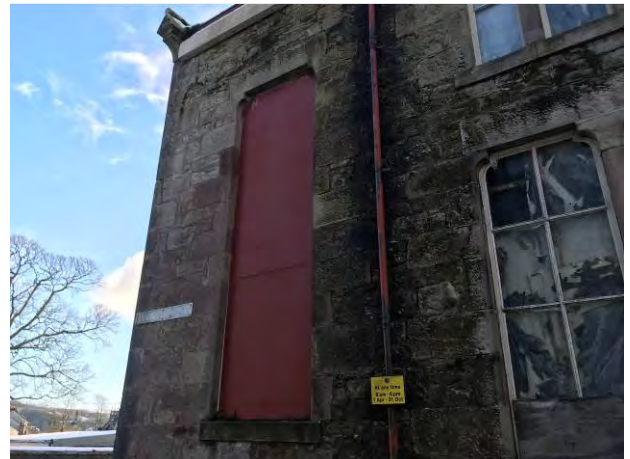
Photo 4. Water staining around downpipe

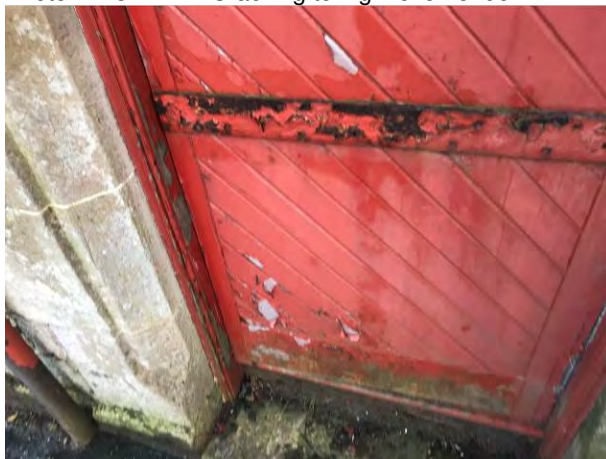
Photo 5. Decaying escape door

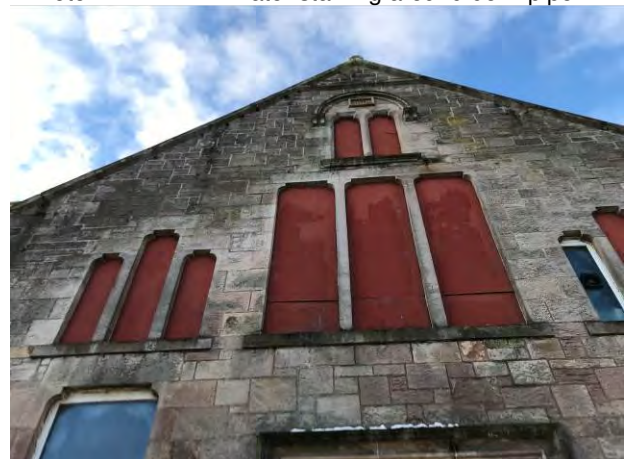
Photo 6. Previous mortar repairs to front elevation

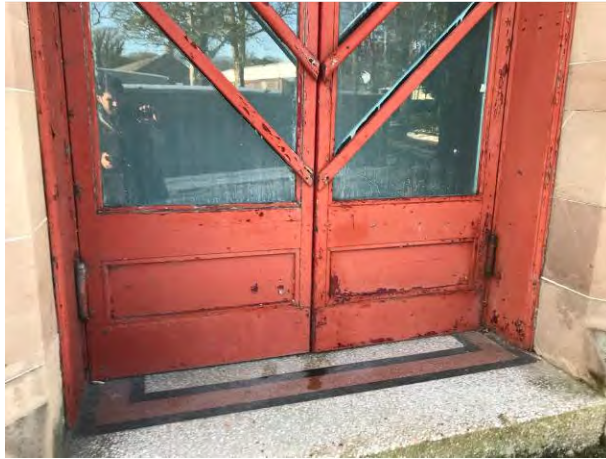
| PROPERTY: Millport Town Hall, Isle of Cumbrae | | | | B.S. SG | Date: Feb 2019 | Job No. BS1454 | | |
|---|---|---|---|--|--|---|---|---|
| <b>North-East<br/>Elevation (Front)</b> | Doors | Solid core timber door | Fair/poor<br>- timber decay at low level and decoration poor | Overhaul door and carry out isolated timber repairs, redecorate (Consider replacing) | U | 150 | | |

Photo 7. Timber decay to front doors

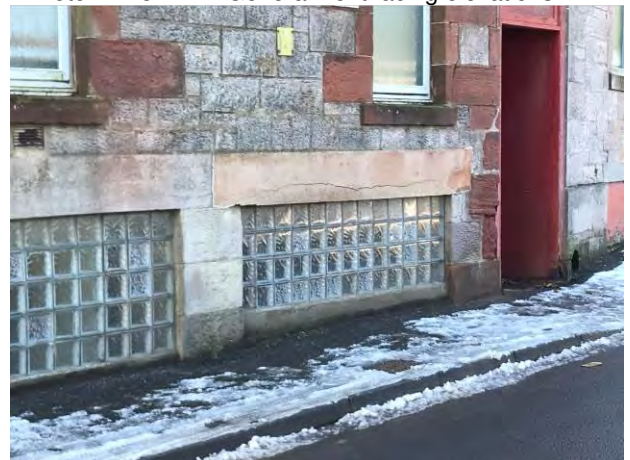
| PROPERTY: Millport Town Hall, Isle of Cumbrae | | | | B.S. SG | Date: Feb 2019 | Job No. BS1454 | | |
|---|---|---|---|--|--|---|---|---|
| | | | Structural repairs<br>- horizontal cracking to lintels above basement toilet window openings | Refer to engineer report for required repairs | U | * | | |

Photo 10. Cracking across lintel to basement windows

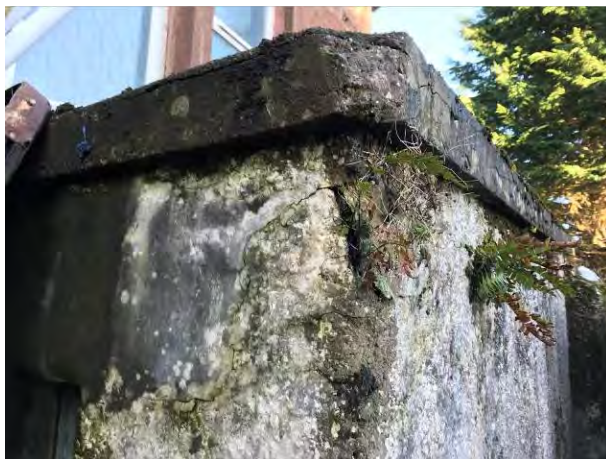
| PROPERTY: Millport Town Hall, Isle of Cumbrae | | | | B.S. SG | Date: Feb 2019 | Job No. BS1454 | | |
|---|---|---|--|--|--|---|---|---|
| | | Structural repairs | - roughcast wall at stairs to basement toilet in poor condition with cracking throughout and vegetation growth | Hack off loose roughcast, repair, and re-roughcast access stairs to basement toilets | U | 600 | | |

Photo 11. Cracking and vegetation growth to basement toilet entrance

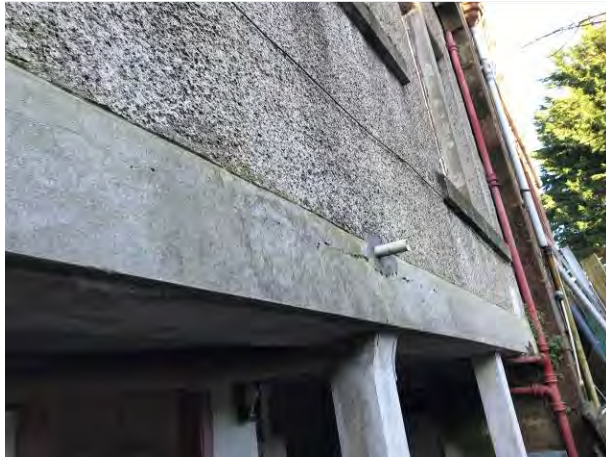
| PROPERTY: Millport Town Hall, Isle of Cumbrae | | | | B.S. SG | Date: Feb 2019 | Job No. BS1454 | | |
|---|---|---|--|--|--|---|---|---|
| | | | Horizontal cracking, corrosion to reinforcement and spalling to concrete structure | Refer to engineer report for required repairs | U * | | | |

Photo 13. General cracking to structure of south-east extensions

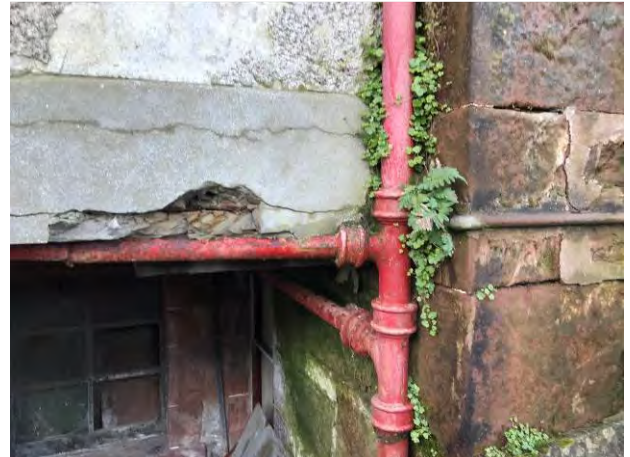
Photo 14. Corrosion to embedded steelwork

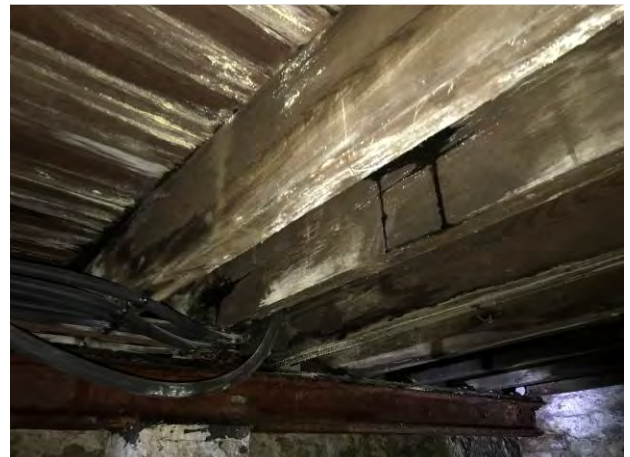
Photo 16. High moisture levels and staining to timbers in basement

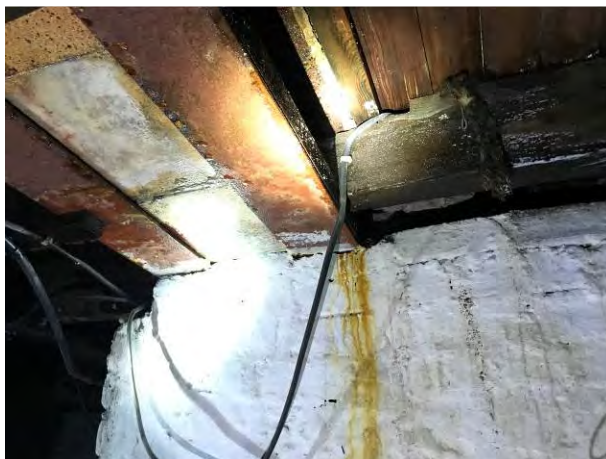
Photo 17. Corrosion to steelwork in basement

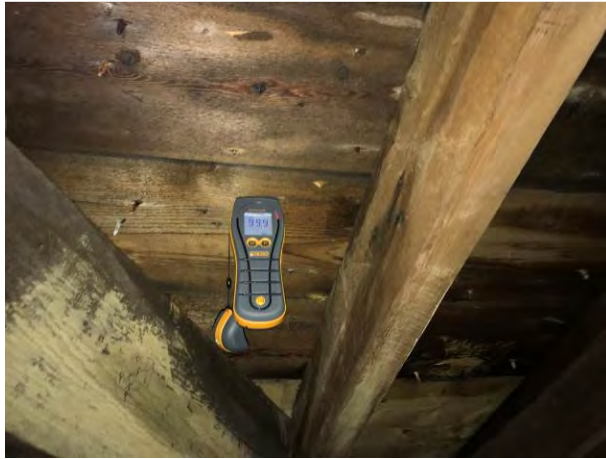
Photo 19. High moisture readings to timber sarking and corroding nail fixings

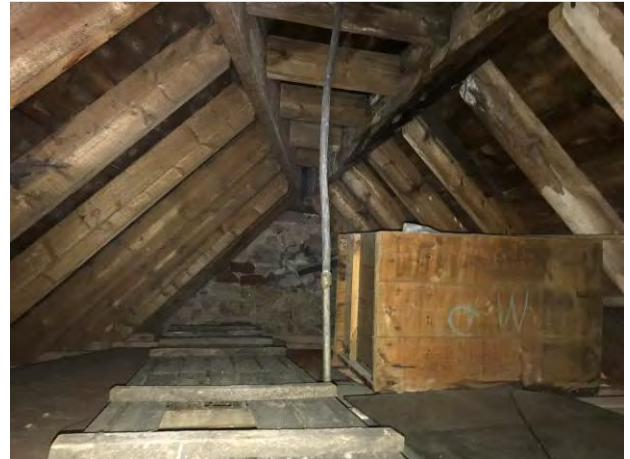
Photo 20. View of water staining and previous timber repairs to roof void

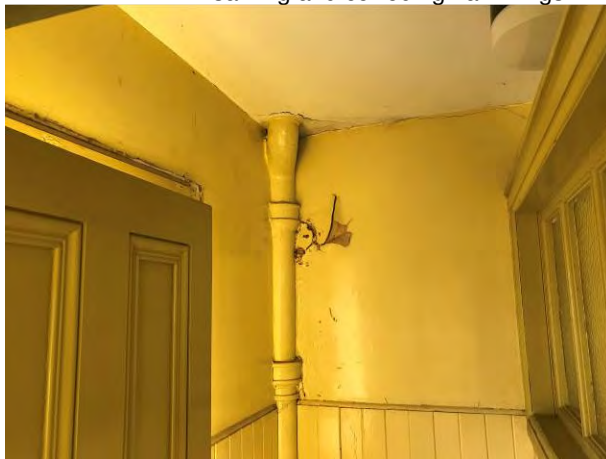
Photo 21. Water damage around downpipe

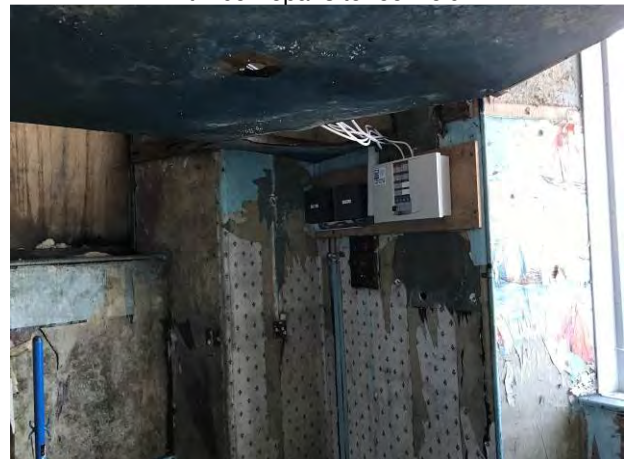
Photo 22. Mould growth and high moisture levels in store at main entrance

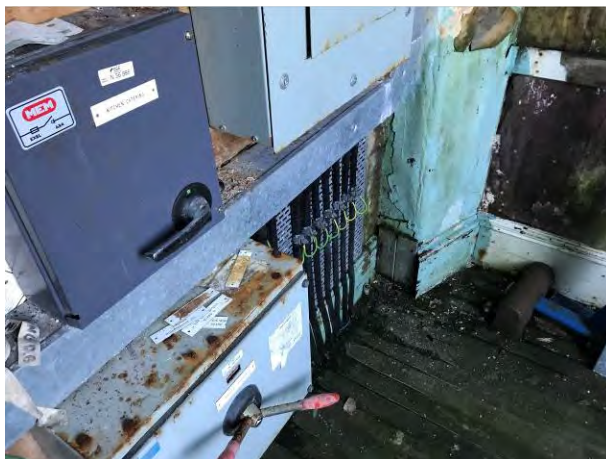
Photo 23. Corroding electrical switchgear

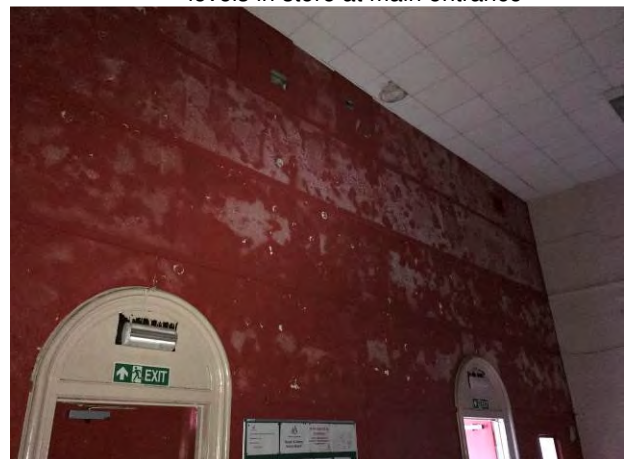
Photo 24. High moisture levels and mould to wall within main hall

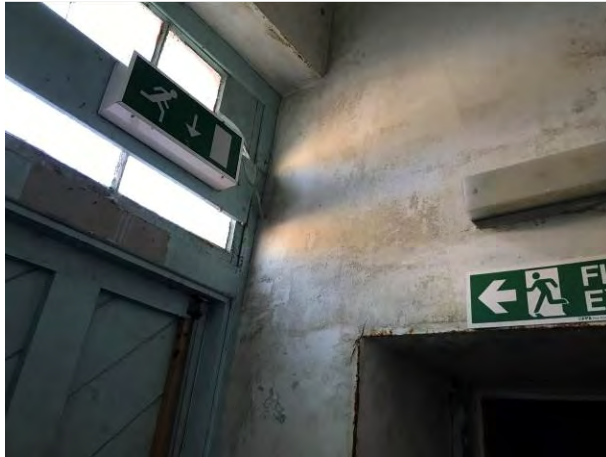
Photo 25. High moisture readings and cracking around door lintels at north-west corner of building

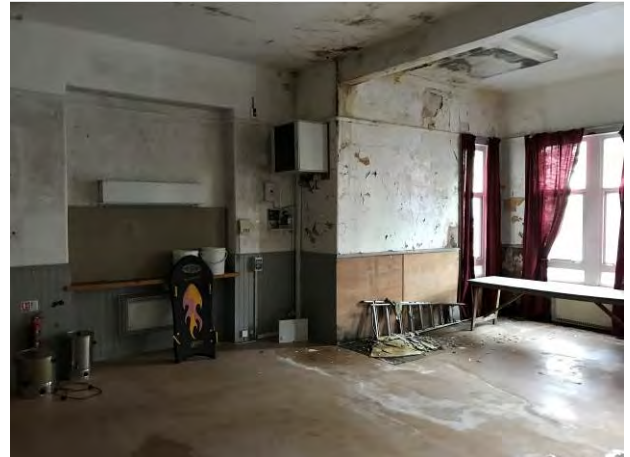
Photo 26. Severe water ingress/damage within room 0/012

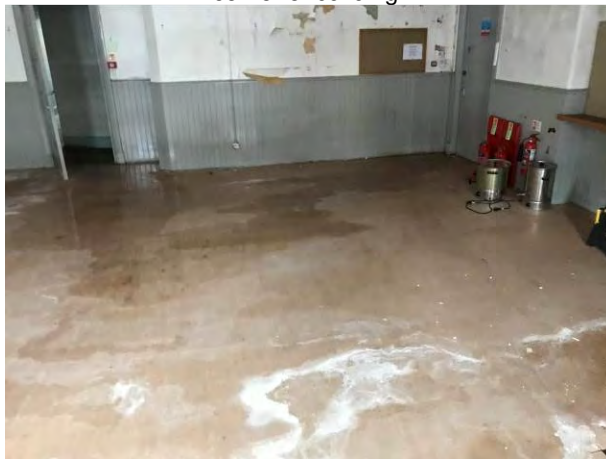
Photo 27. Severe water ingress/damage within room 0/012

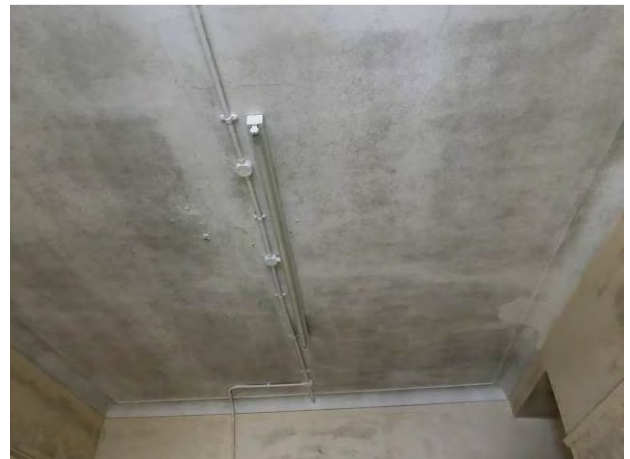
Photo 28. Mould growth to ceiling within room 0/008 Cloakroom

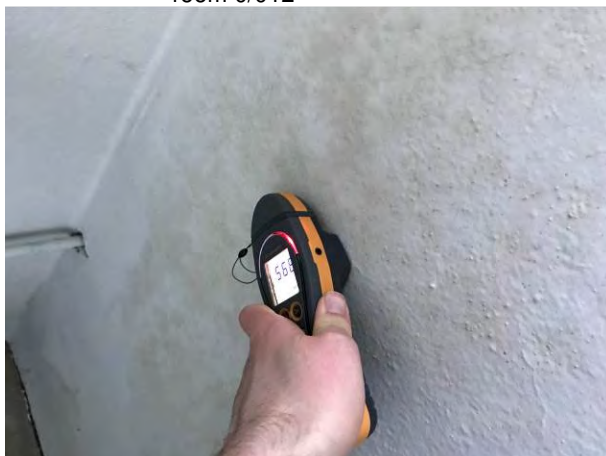
Photo 29. High moisture readings in Male Toilet

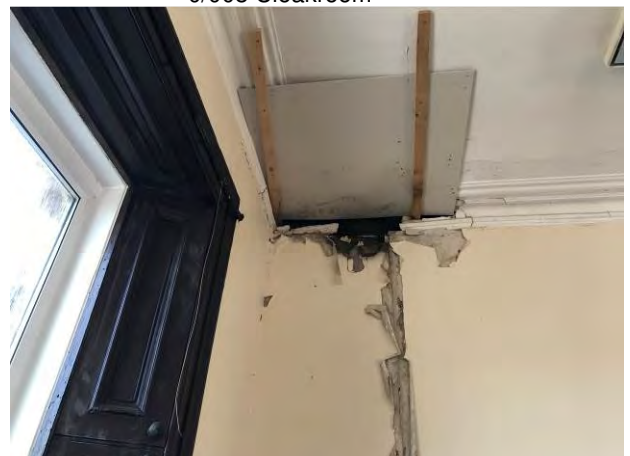
Photo 30. Water damage to ceiling within room 0/007 Office

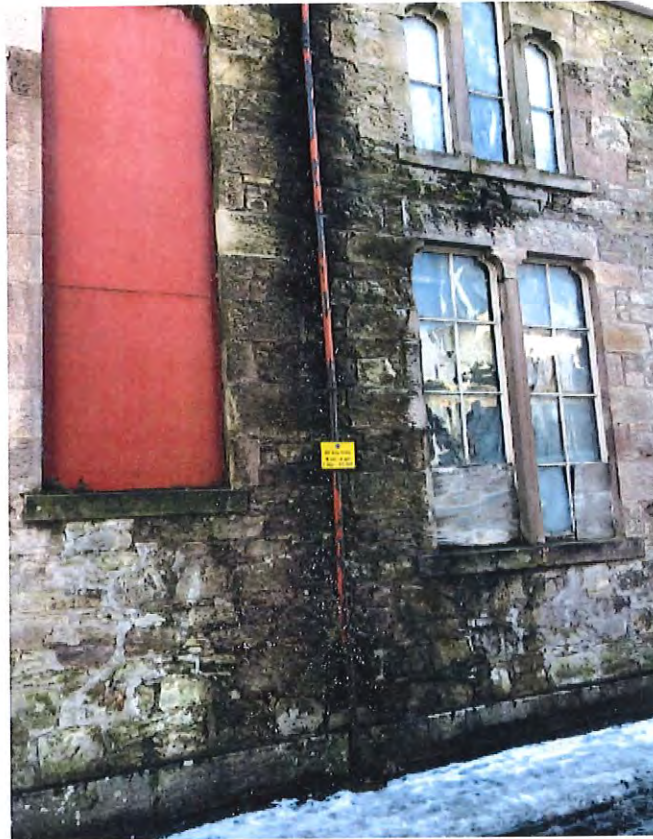
Signs of dampness along Howard Street

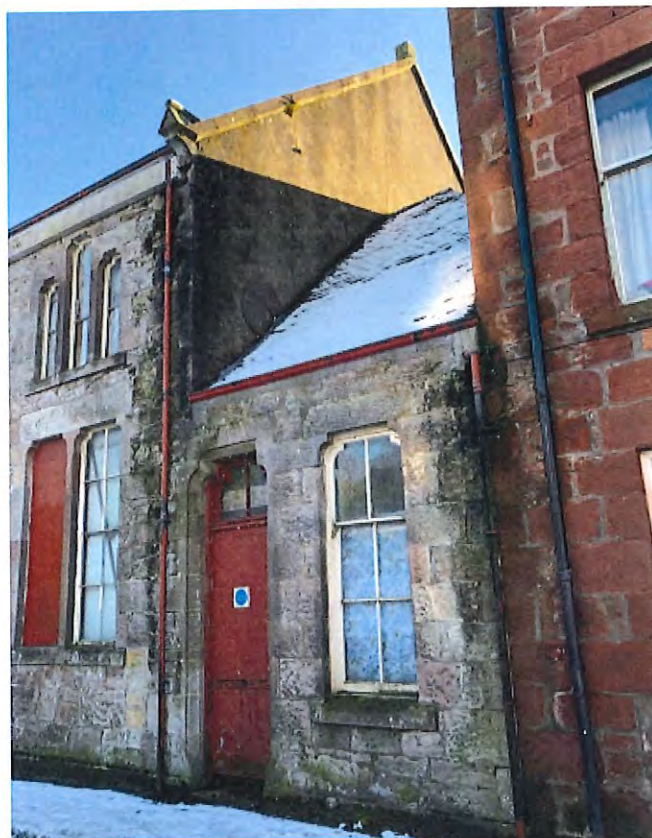
Southwest gable elevation - render cracking

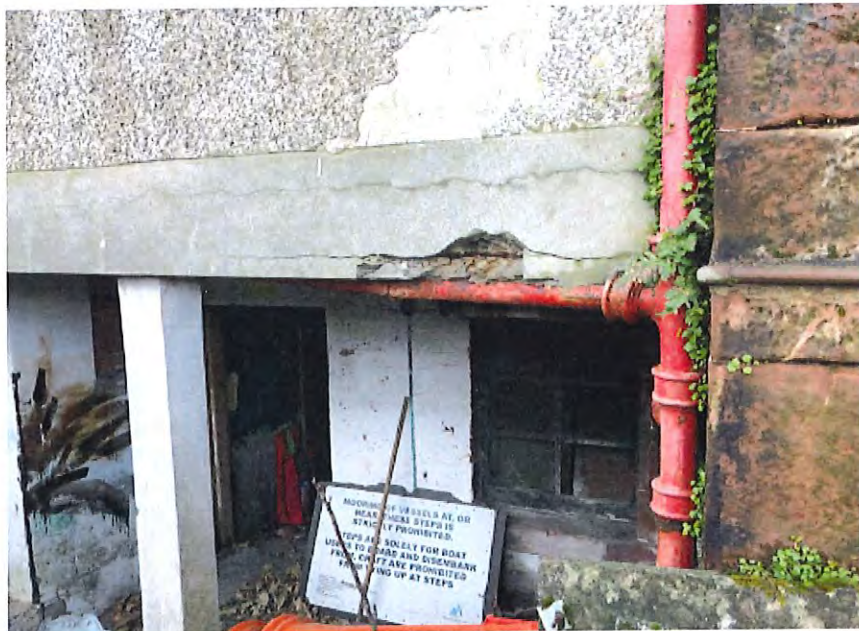
Southeast elevation - Damaged steelwork, concrete & masonry

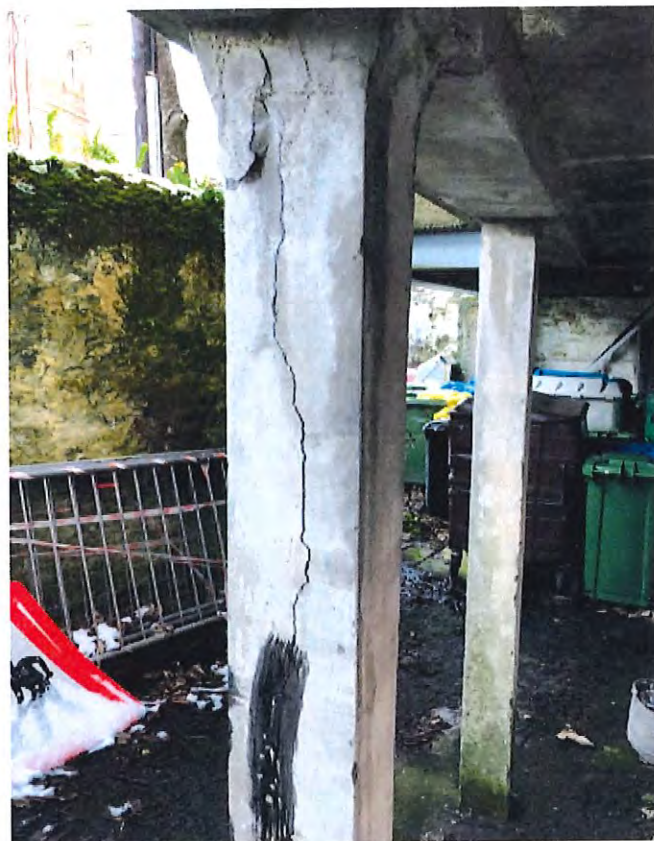
Southeast elevation - Damaged support columns

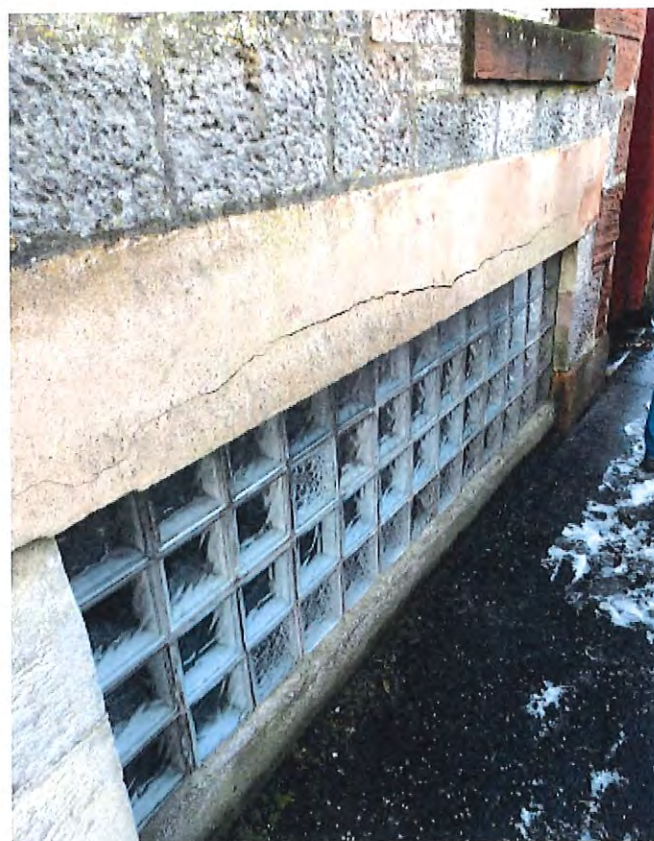
Clifton Street elevation - cracking across lintels

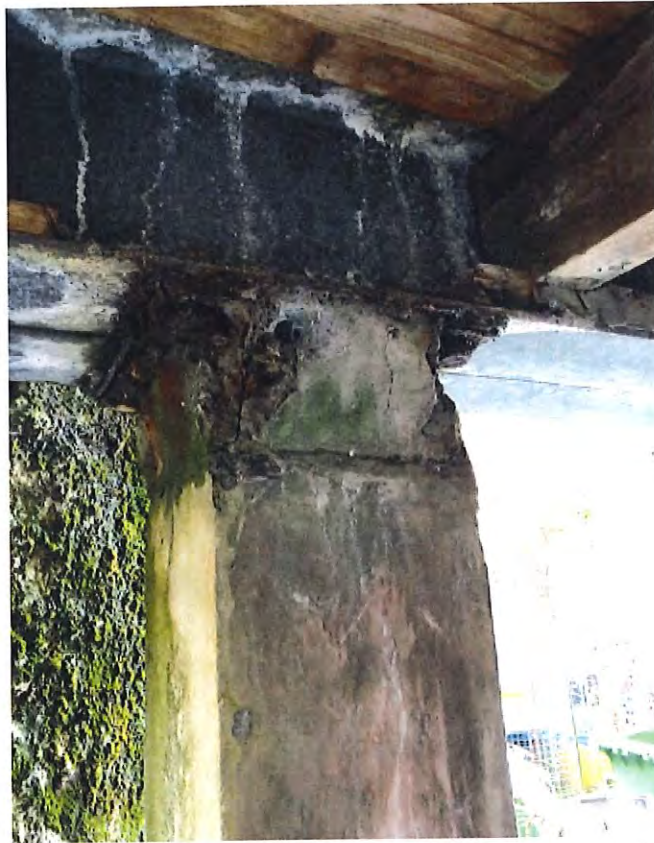
Southeast elevation/undercroft - Damaged steelwork

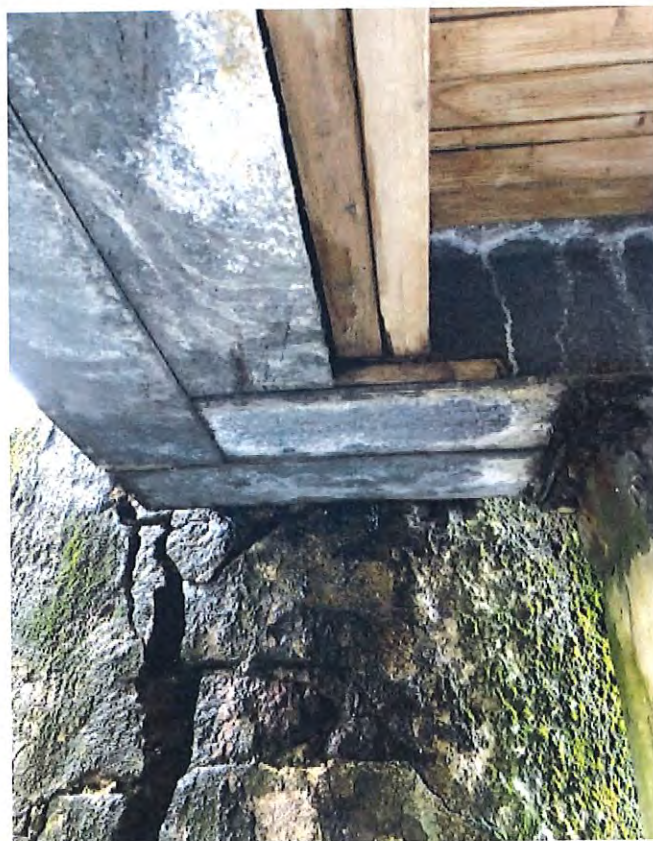
Southeast elevation/undercroft - Damaged masonry

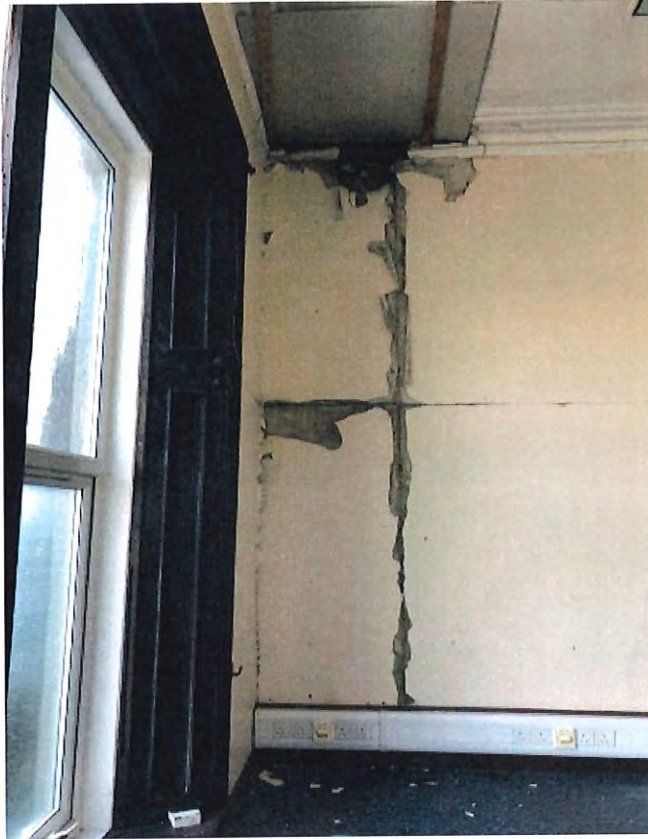
Small hall (along Clifton Street) - Water ingress/dampness

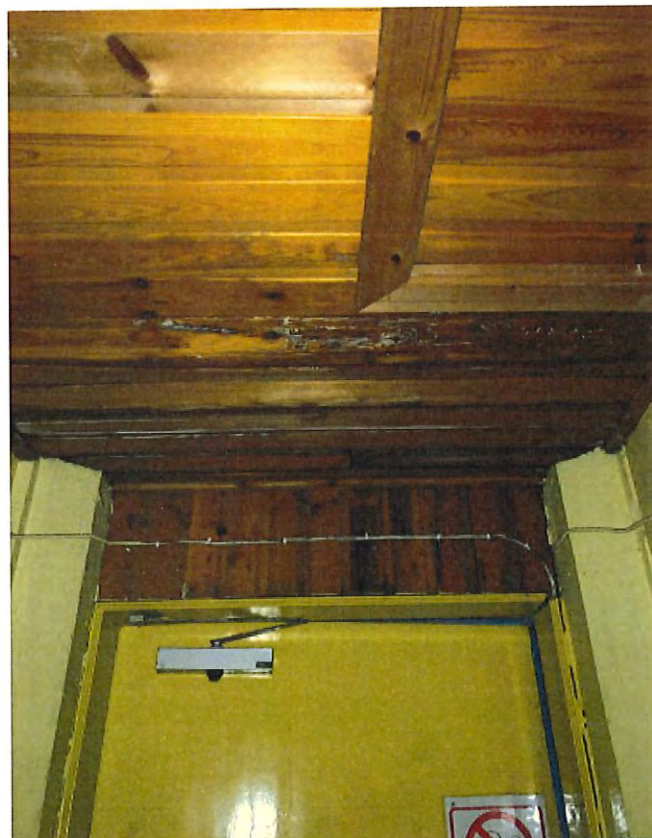
Ground floor hallway - Water ingress/dampness

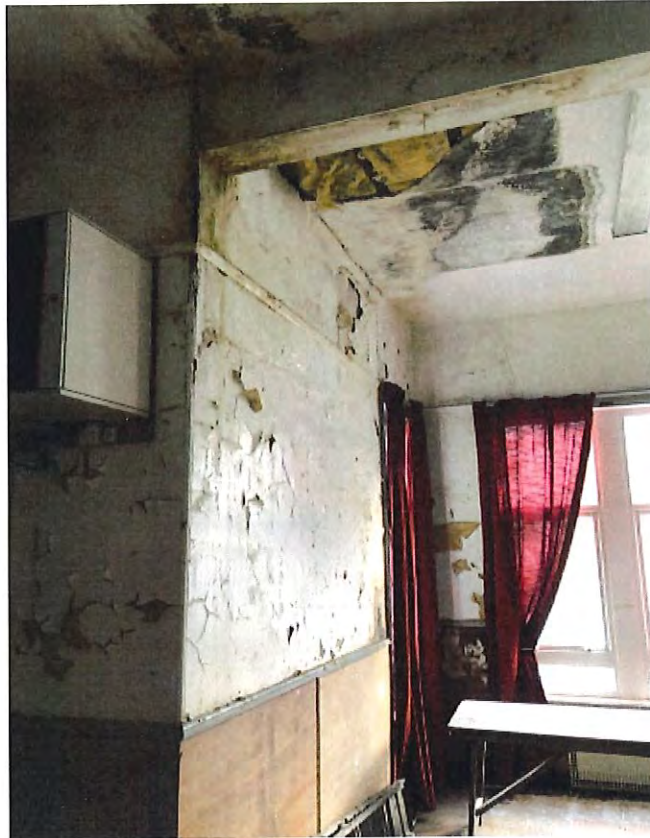
Small rear hall - Water ingress/dampness & damage

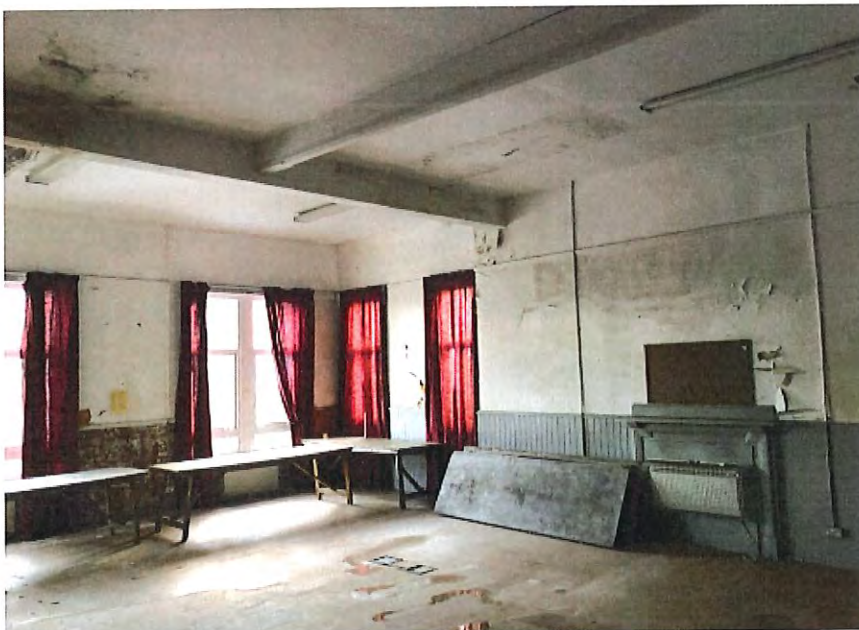
Small rear hall - Water ingress/dampness & damage

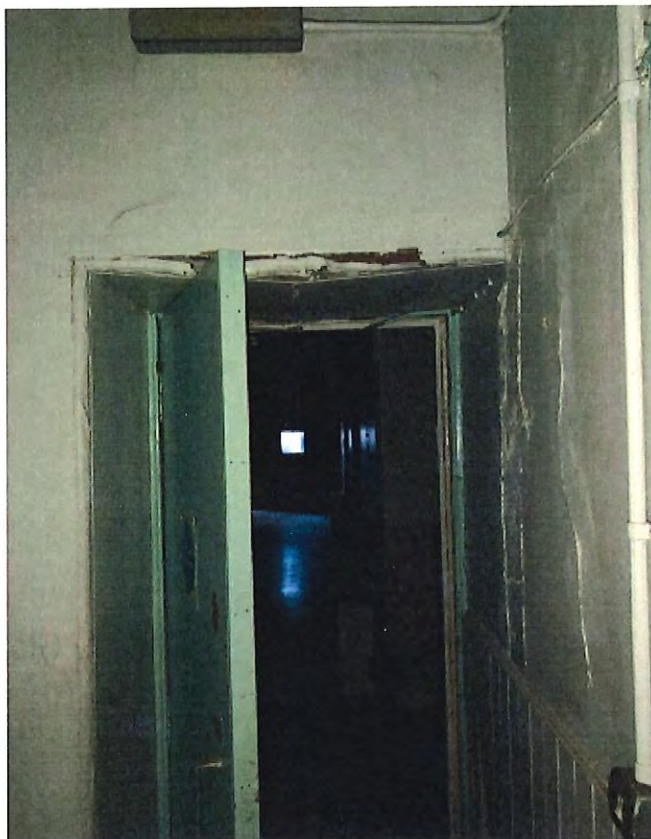
Main hall rear wall (Southwest gable) - damaged lintel(s)

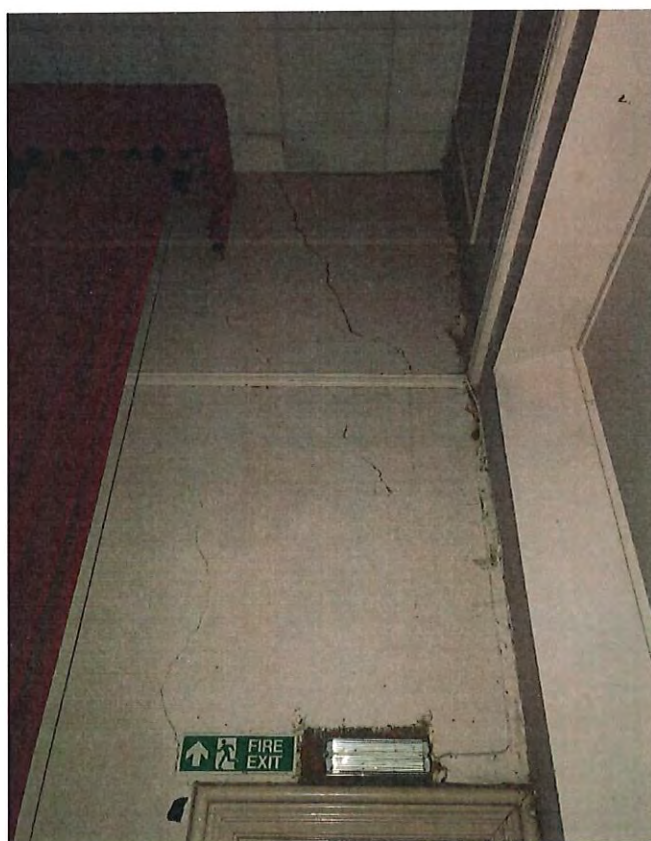
Main hall rear wall (Southwest gable) - cracking

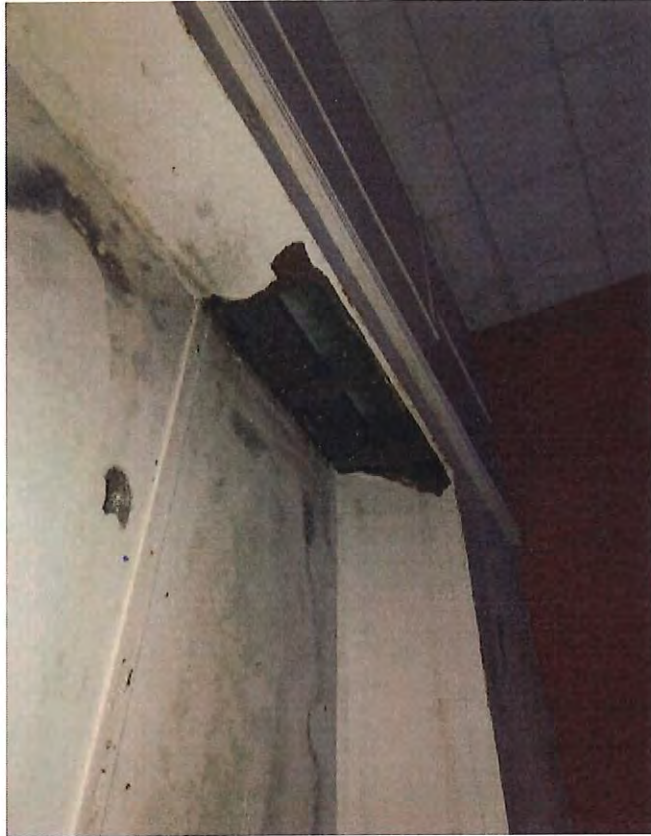
Main hall (Howard Street elevation) - Exposed lintels & water ingress

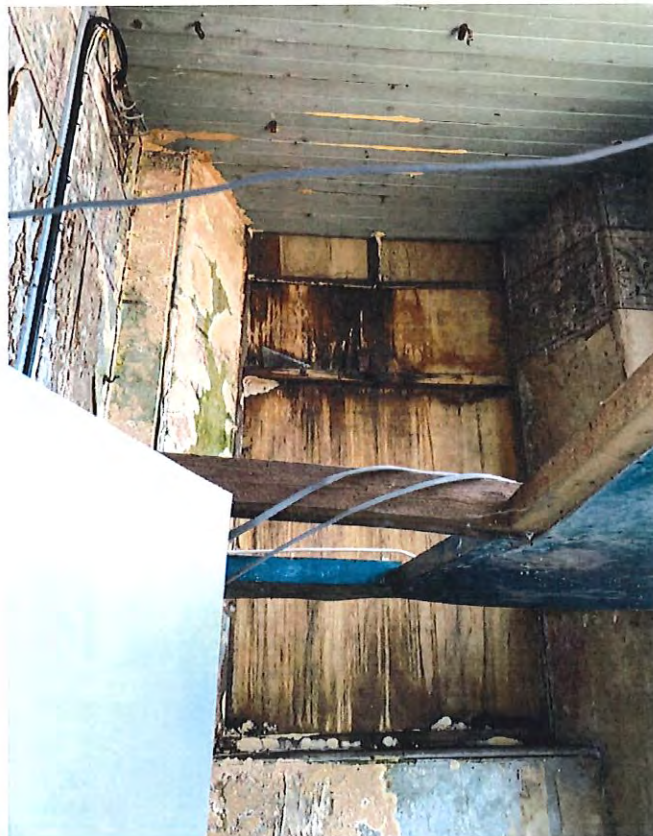
Main hall (Howard Street elevation) - Water ingress/dampness

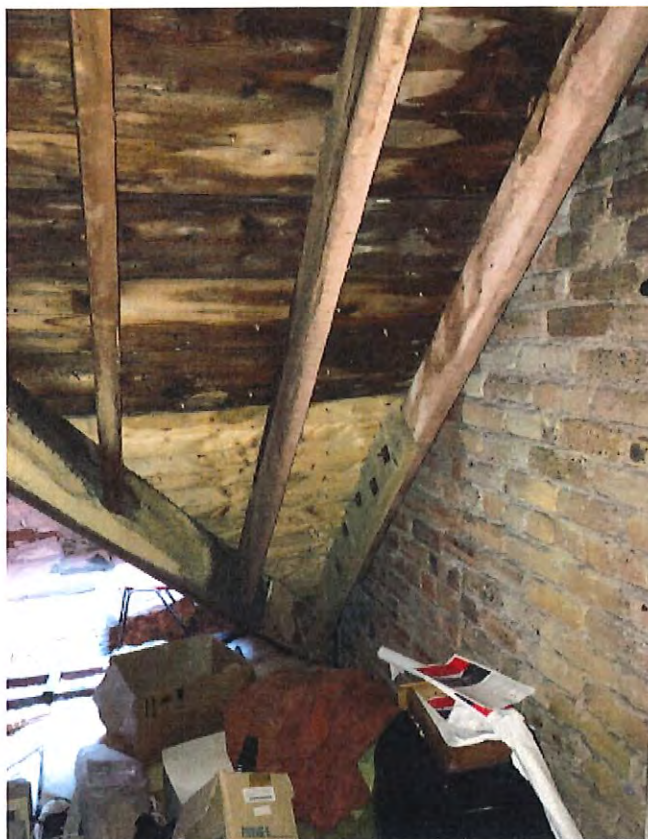
Attic roof void - Signs of dampness/water ingress & previous repairs

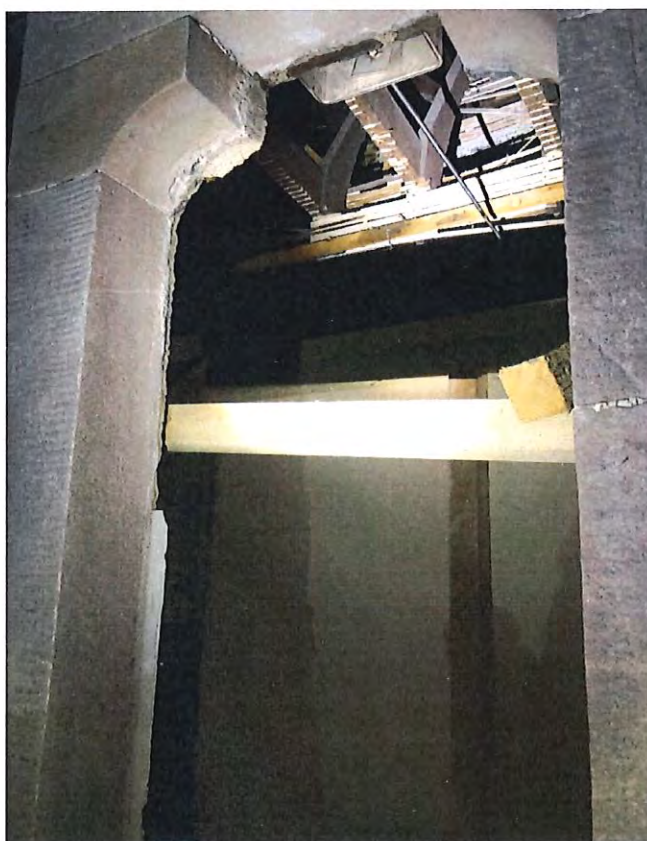
Attic roof void - Previous repairs & remedial works

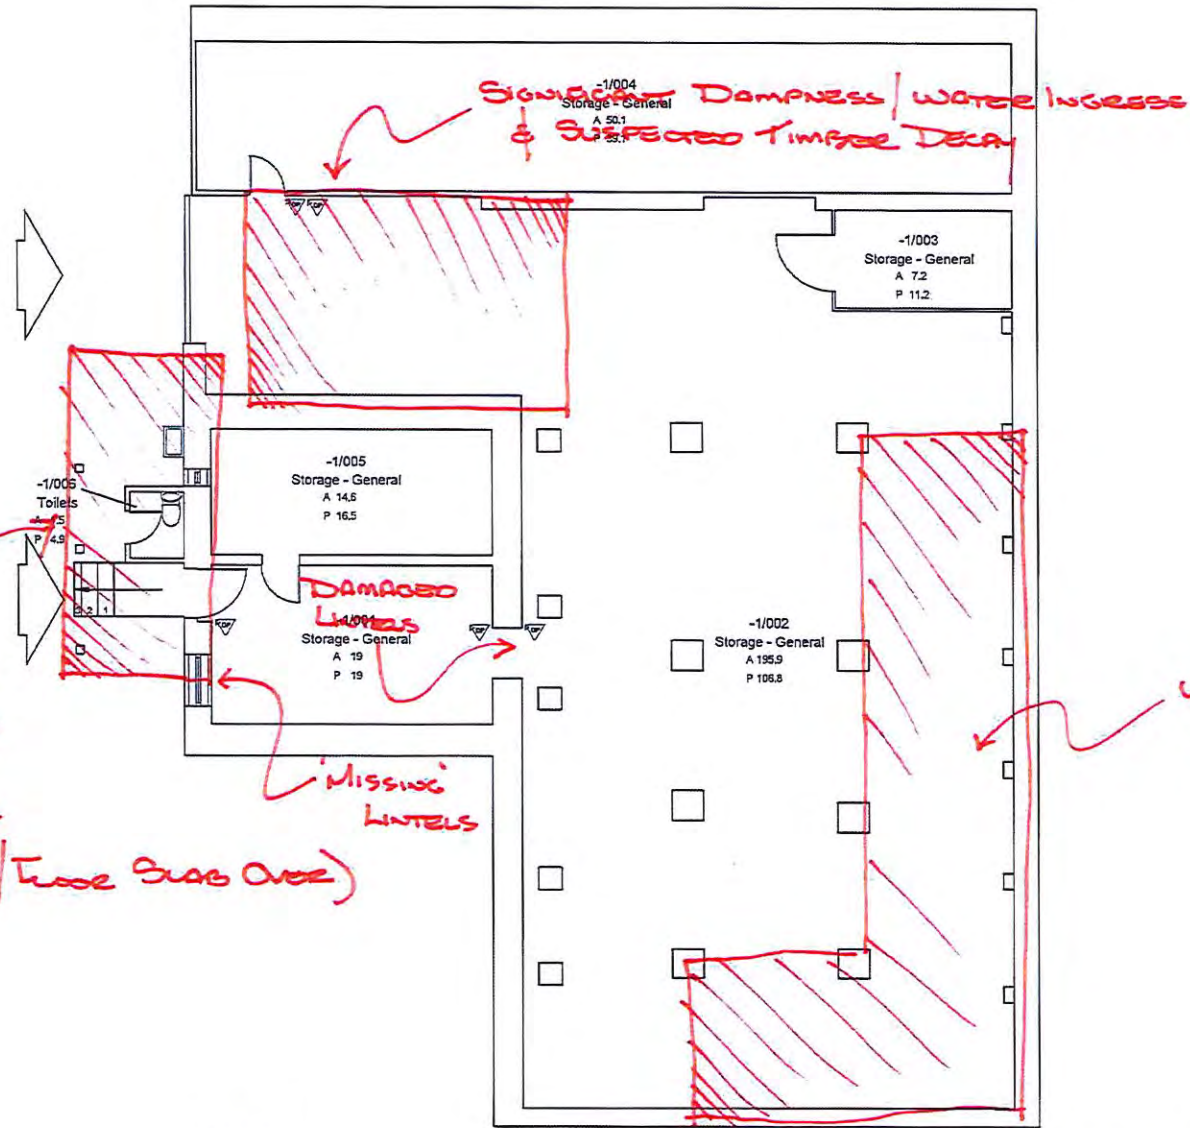
Block 1  
Basement

Cracking Across  
Beams & Columns  
To Be Investigated  
Further - Conc.  
Repair Specialist  
(Including Scaff / True Slab Over)

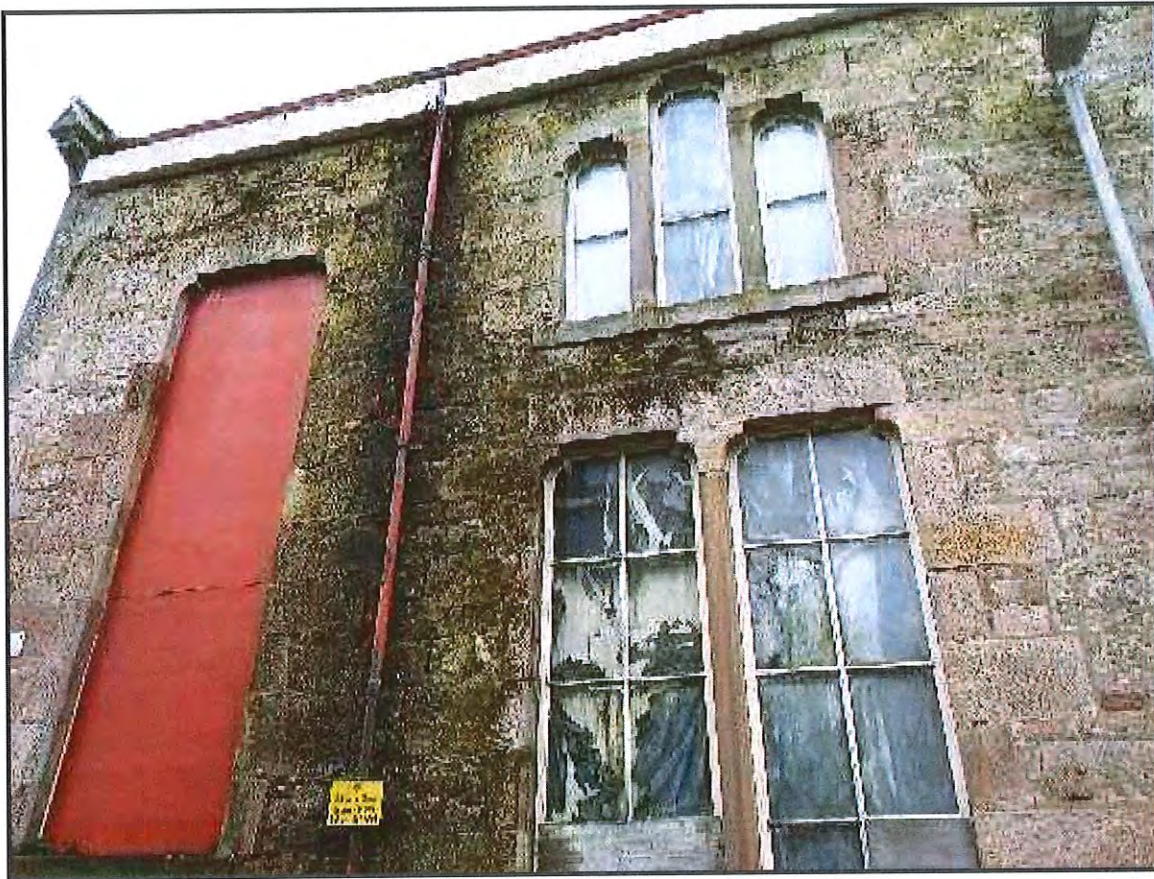
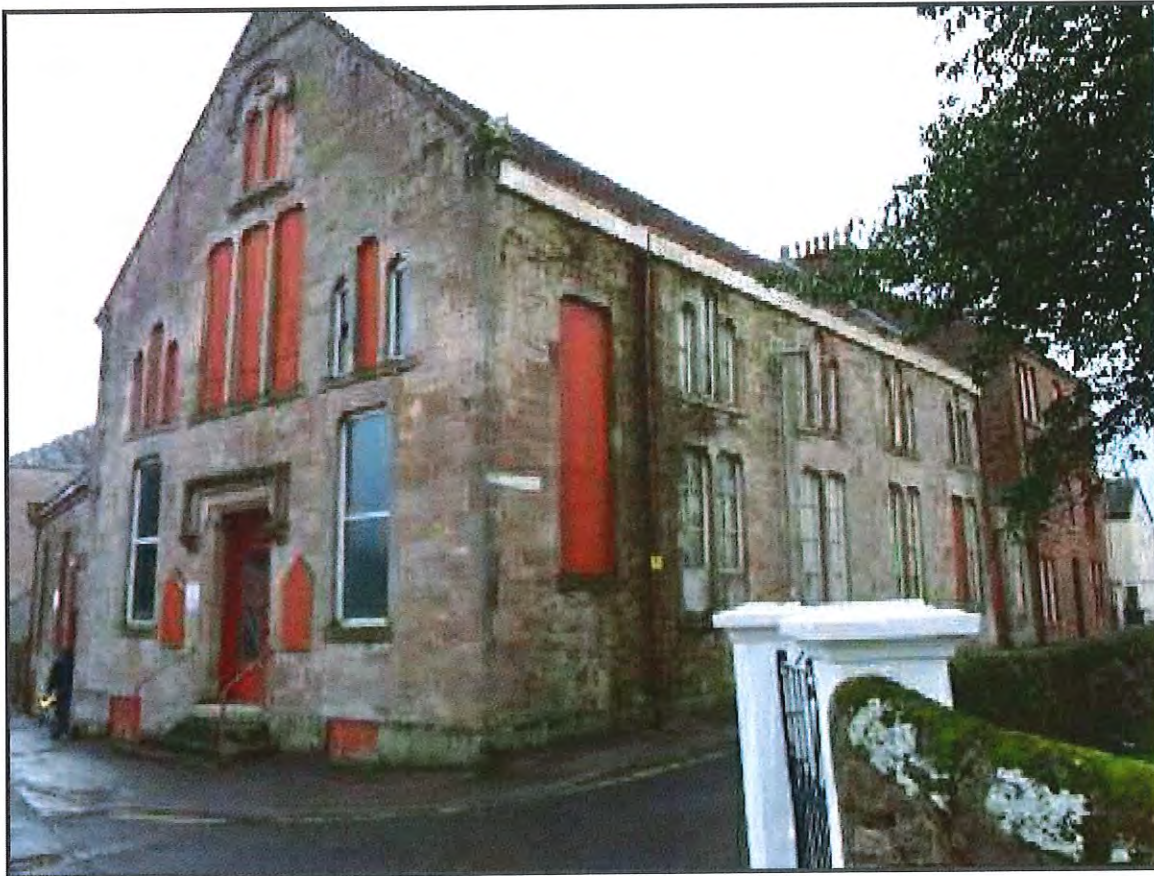
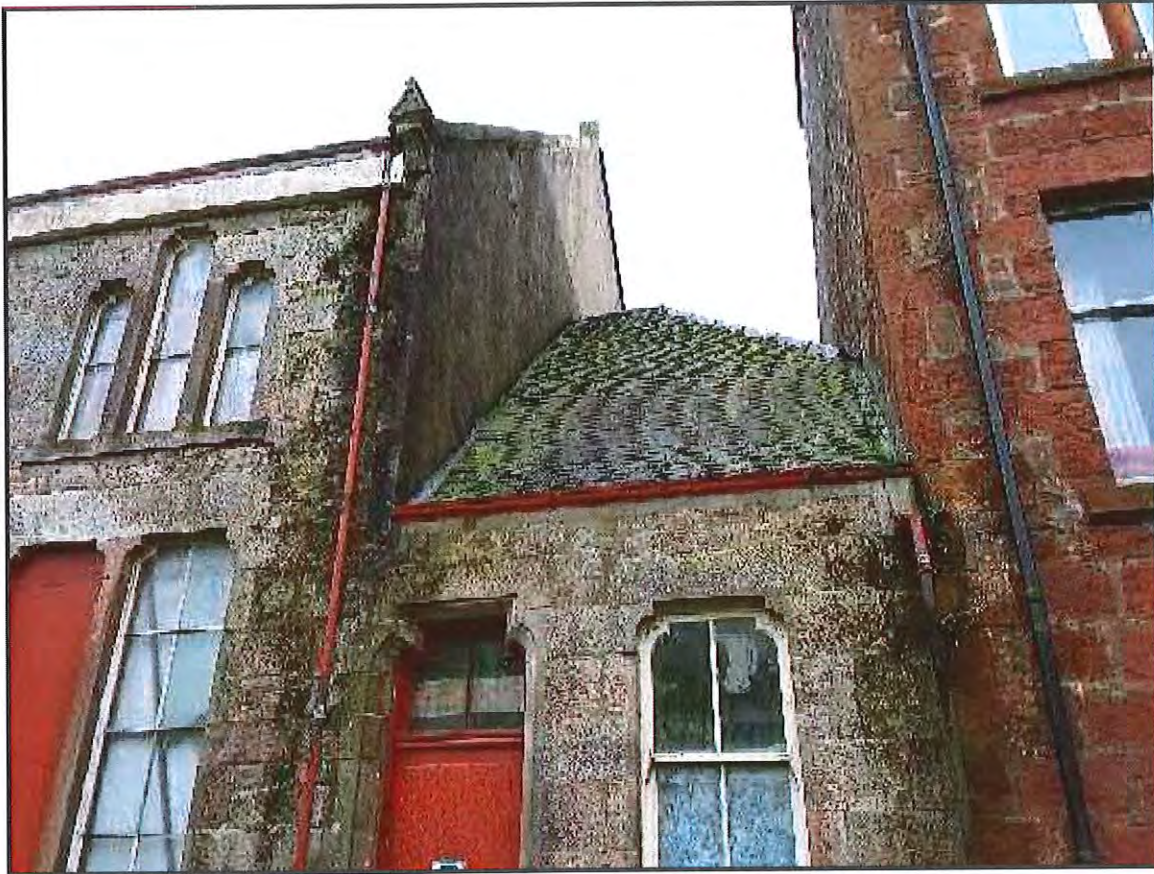
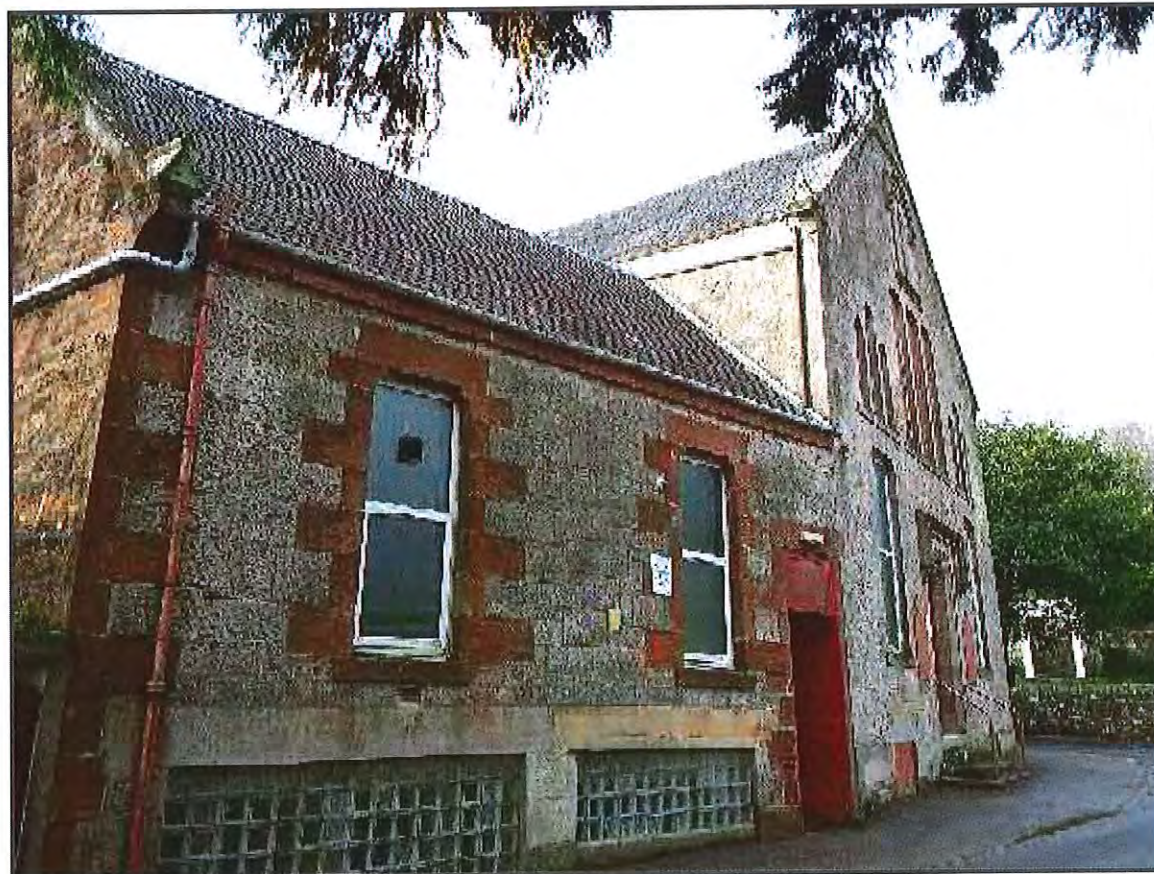
- Defective roof coverings

Client to instruct the services of a reputable roofing contractor to carry out a full survey of all roof coverings and water management systems.

Client to arrange for a reputable building contractor to carry out an external inspection of all masonry including making comment on the existing timber windows.
