**MILLPORT TOWN HALL  
REPAIRS AND CONVERSION TO  
COMMUNITY FACILITY**

**FEASIBILITY COSTS  
FOR**

**BUILDING INSPECTION REPORT**

13277 - Structural Inspection at Millport Town Hall, Millport

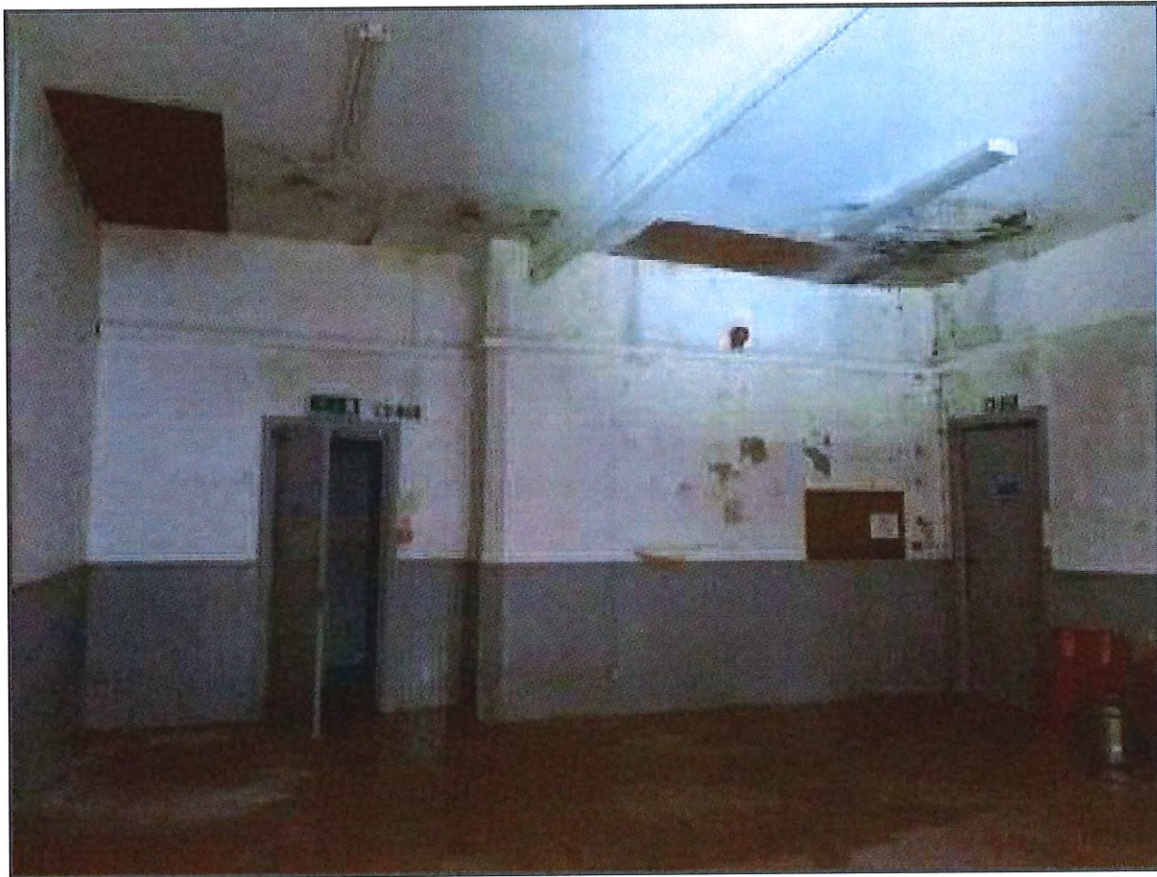
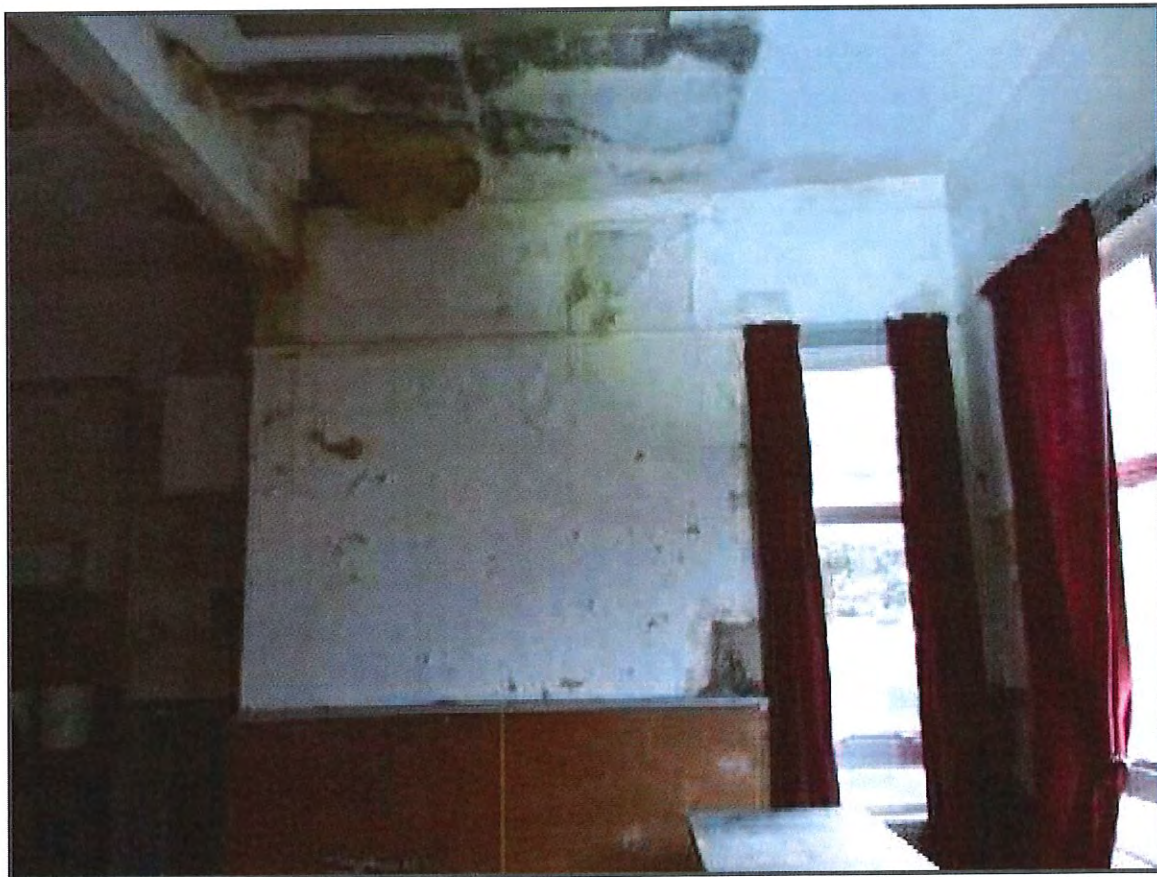
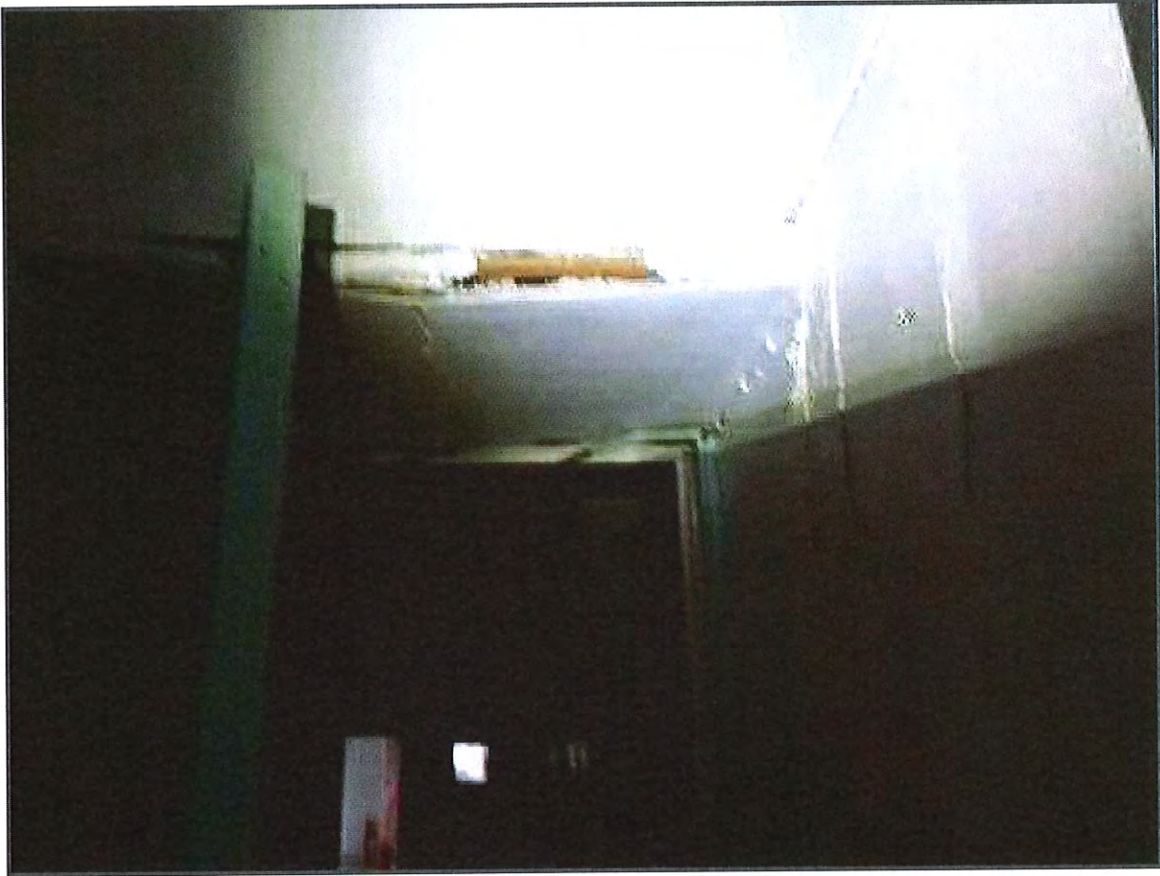
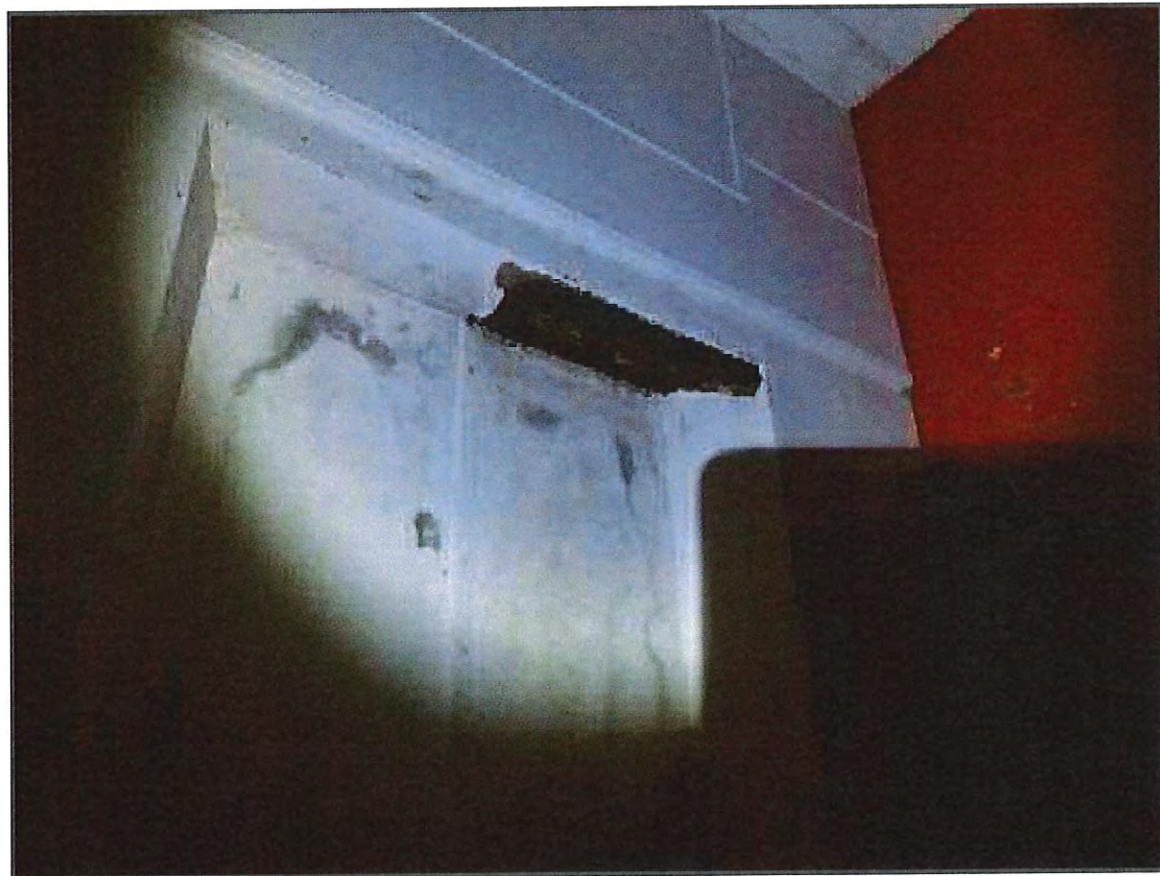
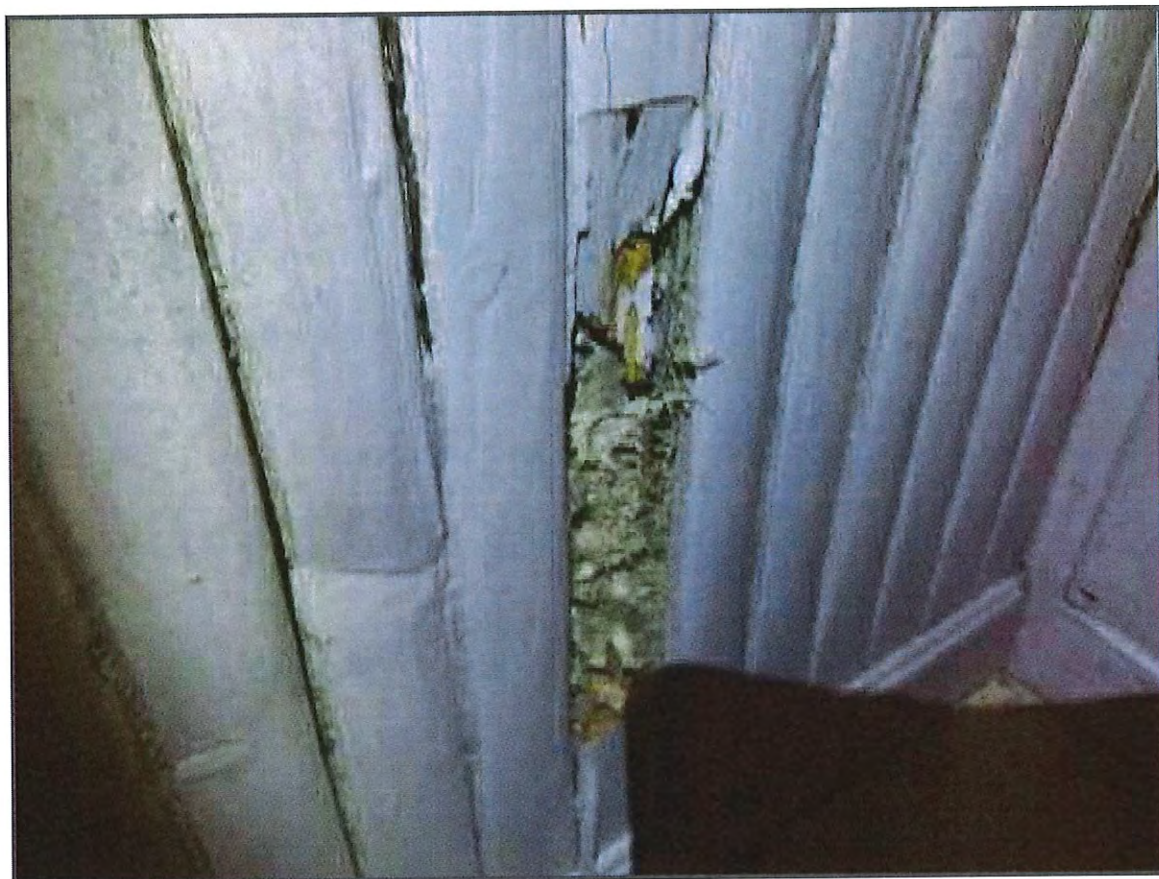
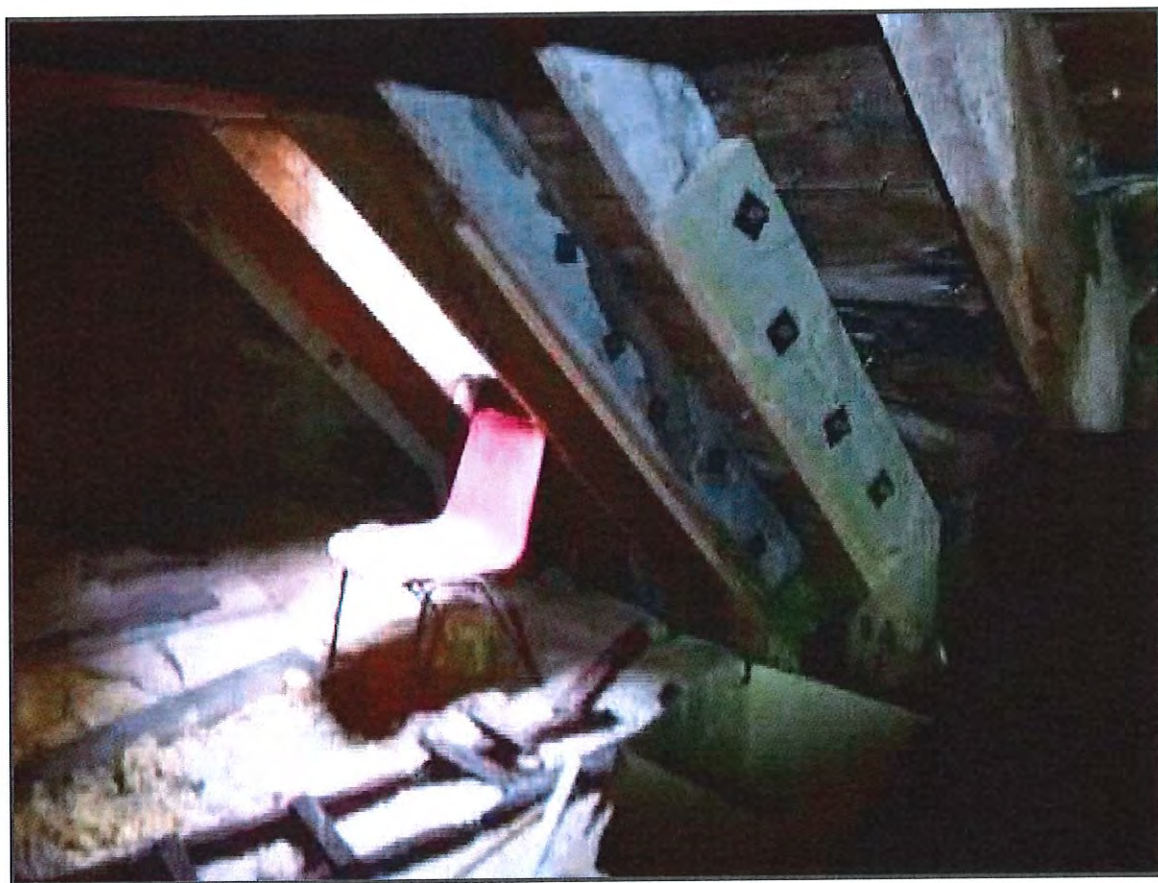
During the course of our visual inspection within the basement block it was noted that the construction of the ceiling/ground floor joists would appear to consist of an internal perimeter steel ring beam which is supporting the ground floor joists. The ground floor joists appear not to be built into the masonry where visually inspected.

Our inspection also revealed areas of water staining to the underside of the ground floor joists/T&G flooring where viewed from within the basement. Our inspection at ground floor level confirmed the presence of water lying on the top surfaces of floor coverings suggesting ingress from roof coverings.
