How to protect Stuart Street

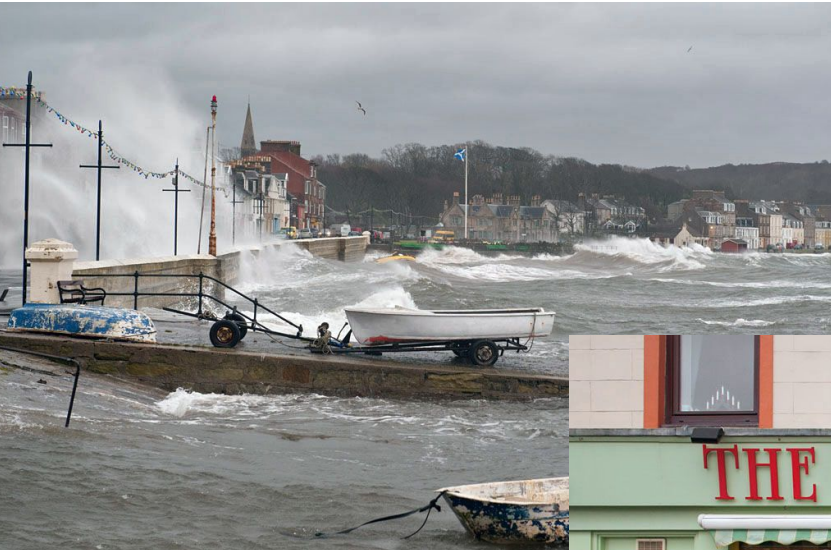
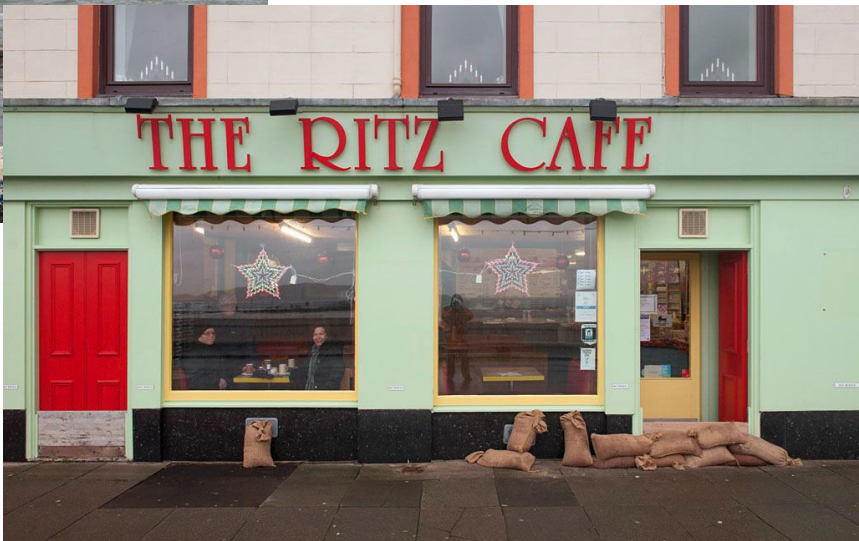
- During heavy storms waves break over the top of the vertical sea wall along Stuart Street.

- Wave overtopping is dangerous for people and vehicles, and causes regular flooding of seafront properties, including local businesses.

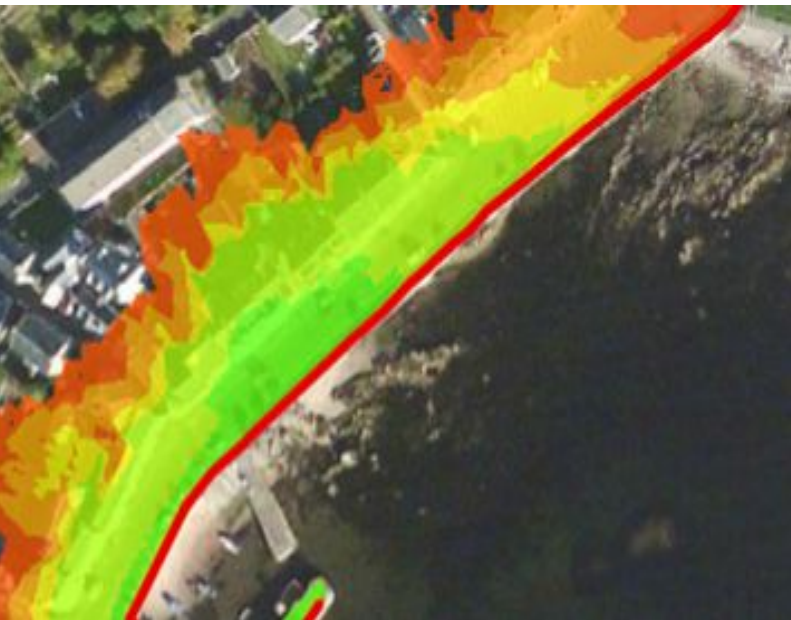
Higher sea wall

Our modelling shows that if seawalls were raised along Stuart Street the homes and businesses would still be at significant risk of flooding. This option would also affect views out to

sea. This option is not considered further as it does not provide enough protection.

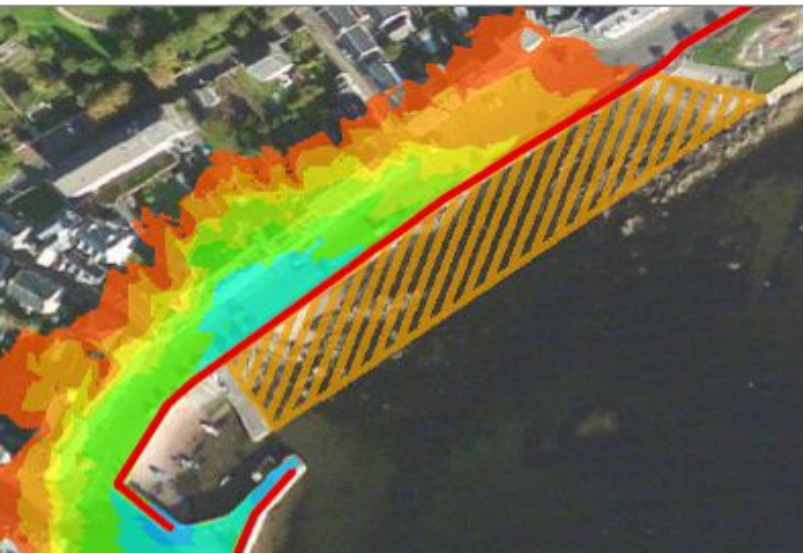
Rock revetment & higher sea wall

If rock armour protection was to be added in front of the sea wall the flood risk reduces. But the height of the sea wall would still need to be increased, and there would continue to be flooding on severe storms. This option is not considered further as it does not provide enough protection.

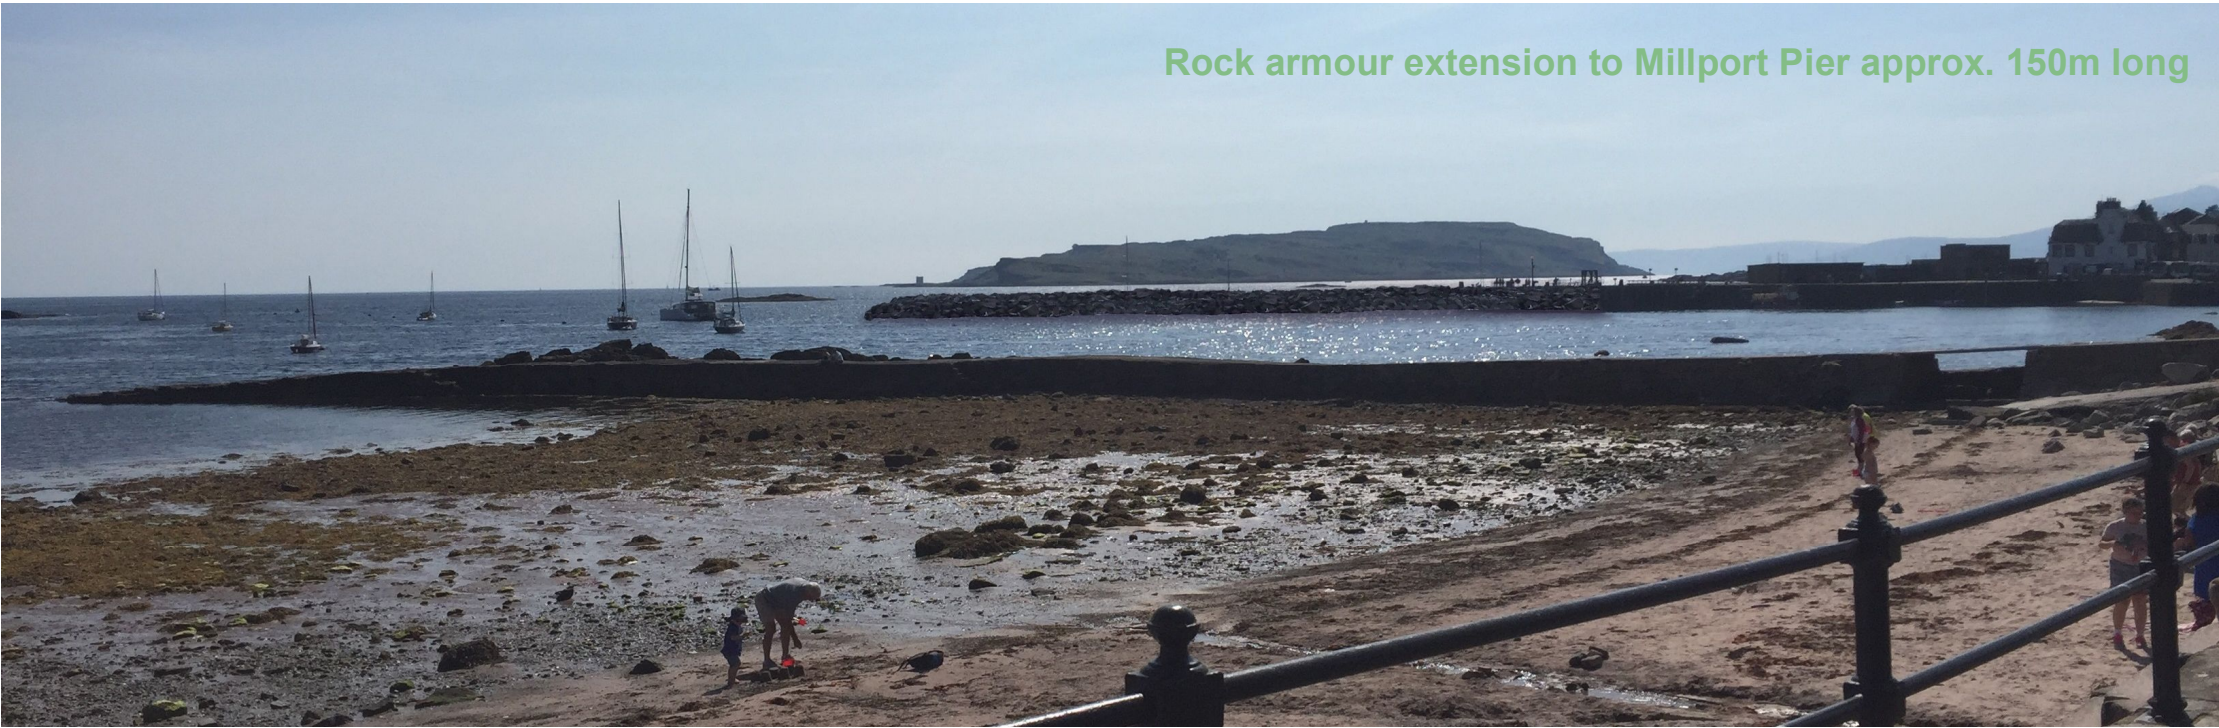
Extending Millport Pier

This solution comprises an extension to the pier constructed from large rocks (rock armour). The existing masonry section of the pier would also be repaired and reinforced with a rock armour toe.

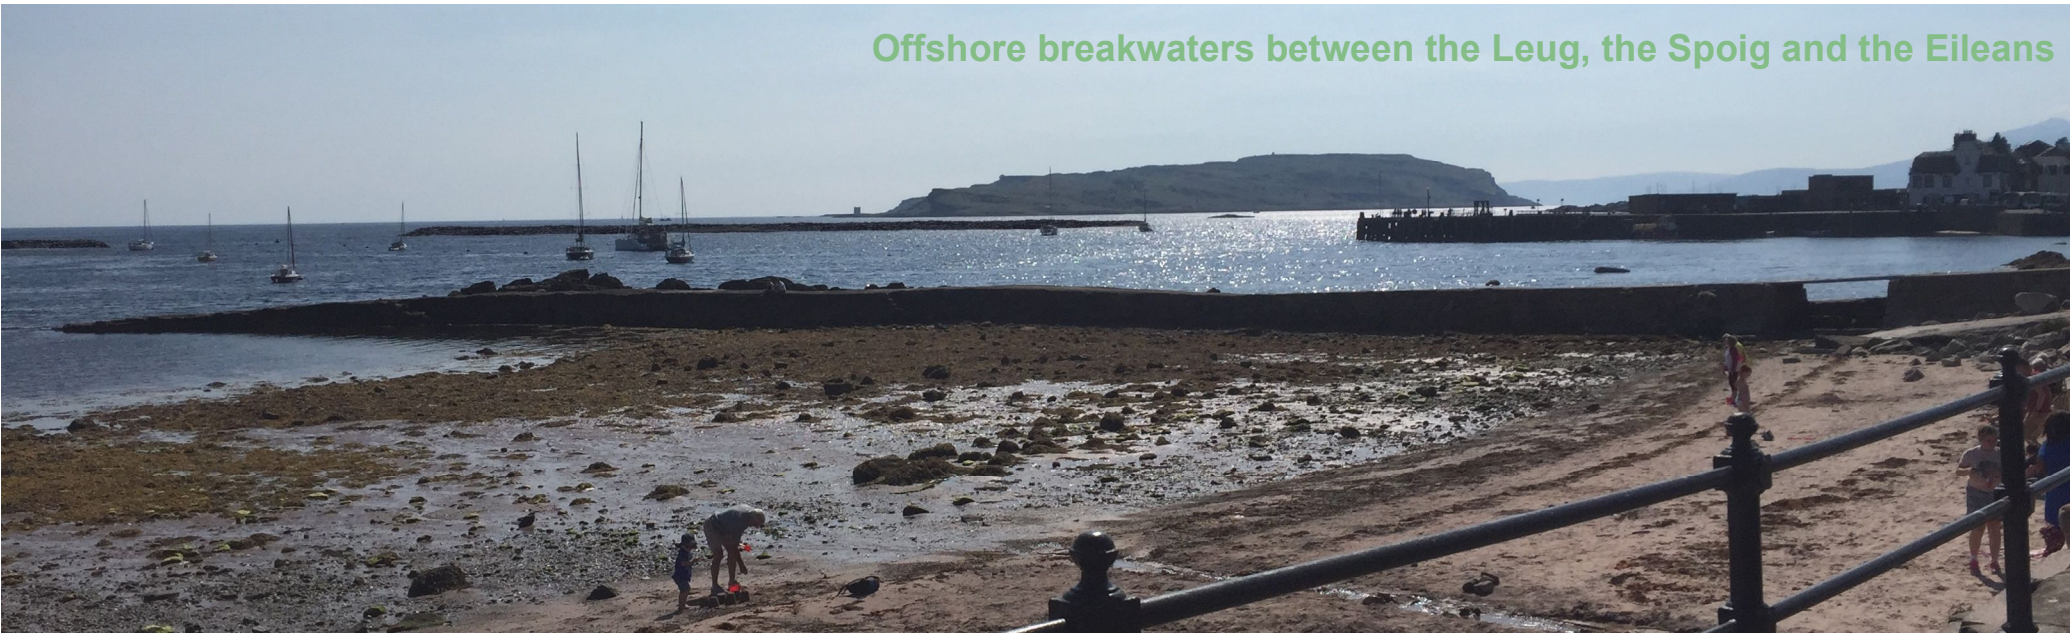
Offshore breakwaters

With this solution, a rock armour breakwater would be built between the Leug and the Spoig rock outcrops in Millport Bay. Breakwaters would also extend into the channel between the Leug and the Eileans, whilst maintaining navigation access through this channel.

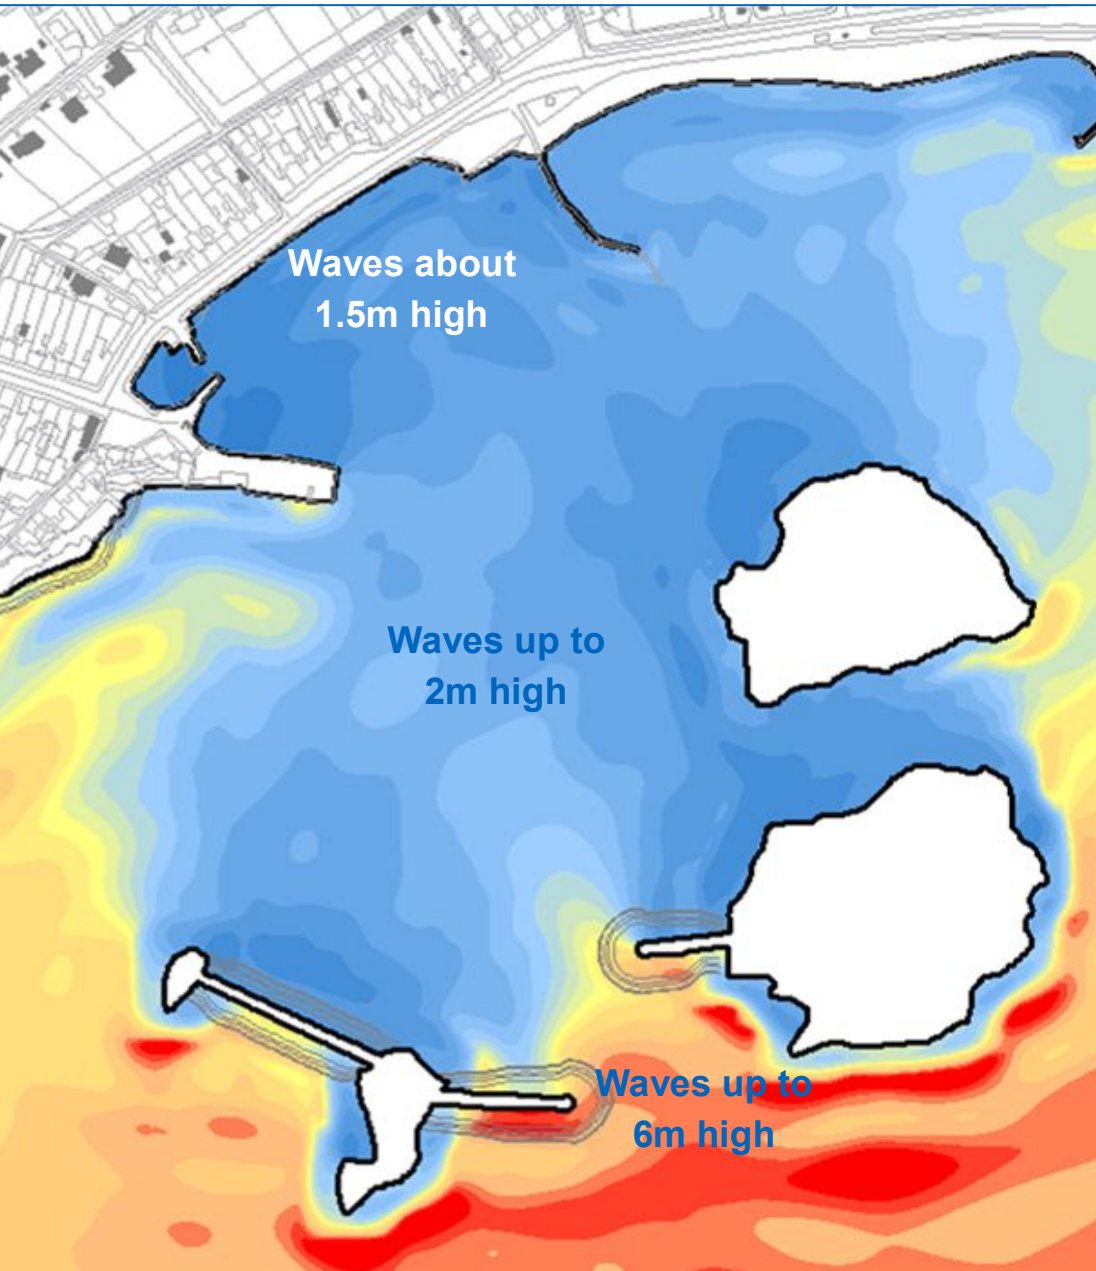
Wave modelling results with offshore breakwater
(storms occurring every 200 years on average, 0.5% probability)

This option would reduce wave heights at the sea wall to about 1.5m on the most severe storms. There would still be some overtopping and flooding on severe storms unless additional works were undertaken to raise the height of the Stuart Street sea wall.
