**MILLPORT TOWN HALL  
REPAIRS AND CONVERSION TO  
COMMUNITY FACILITY**

**FEASIBILITY COSTS  
FOR**

**BUILDING INSPECTION REPORT**

13277 - Structural Inspection at Millport Town Hall, Millport

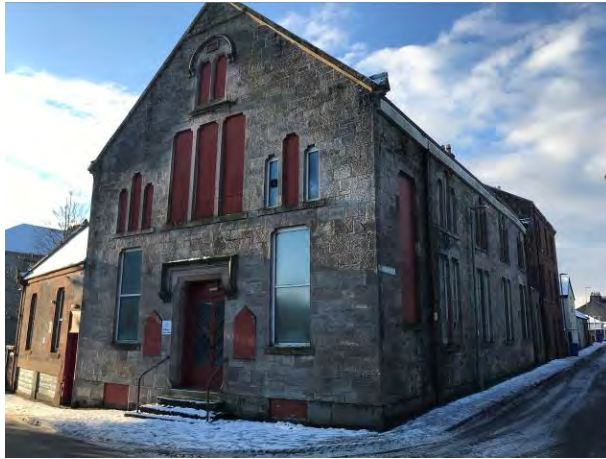
Photo 1. General front elevation

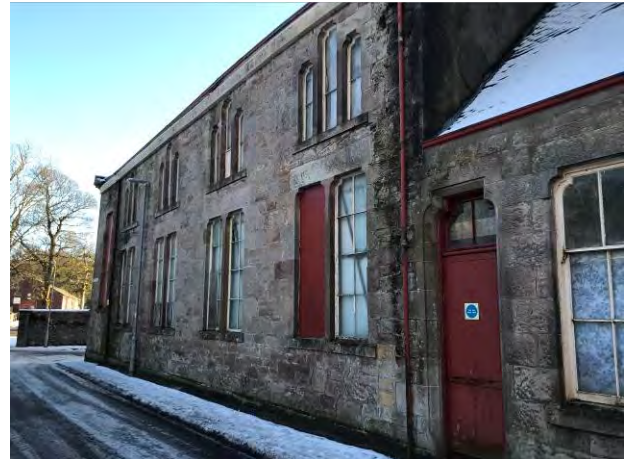
Photo 2. General Howard Street elevation

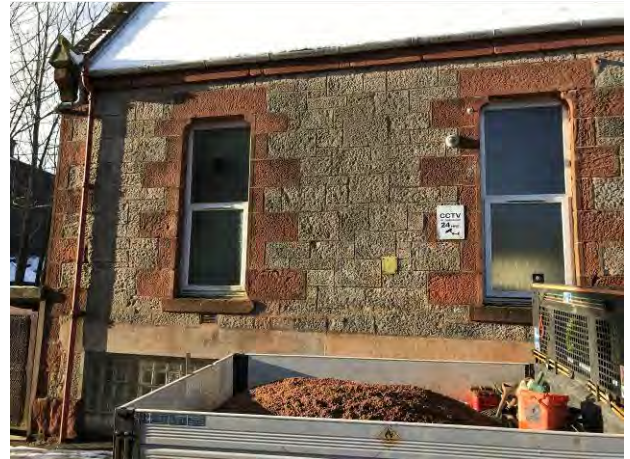
Photo 8. General front facing elevations

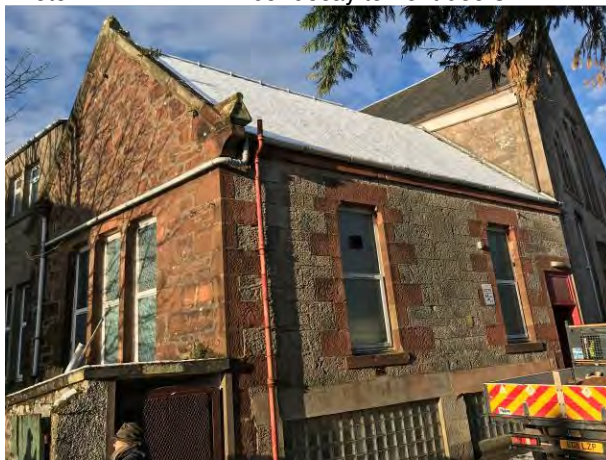
Photo 9. South-east corner elevations

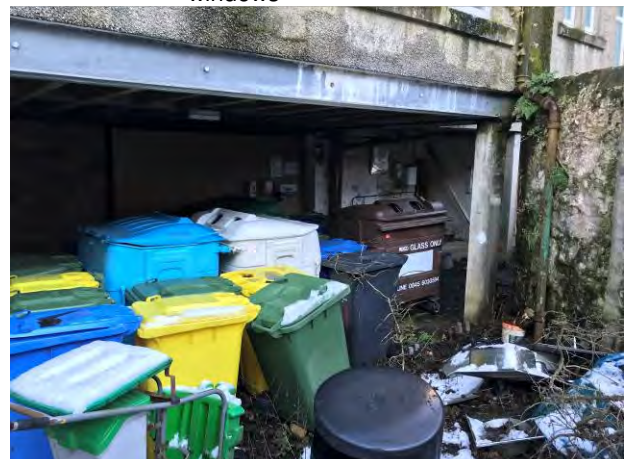
Photo 12. General view of grounds

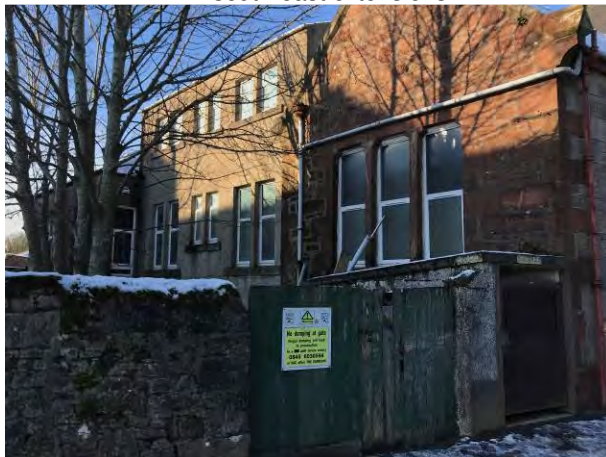
Photo 15. General of south-east elevations

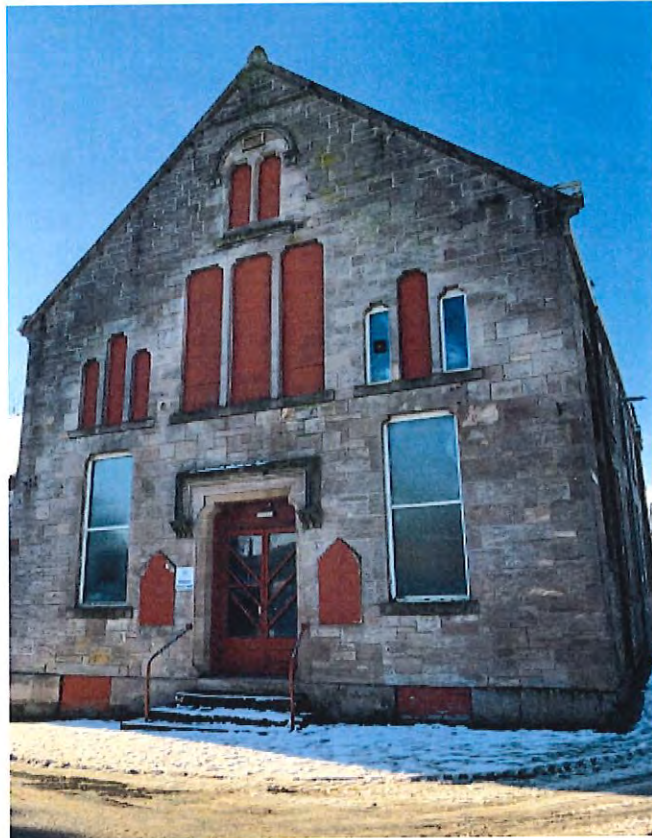
Front (Clifton Street) elevation

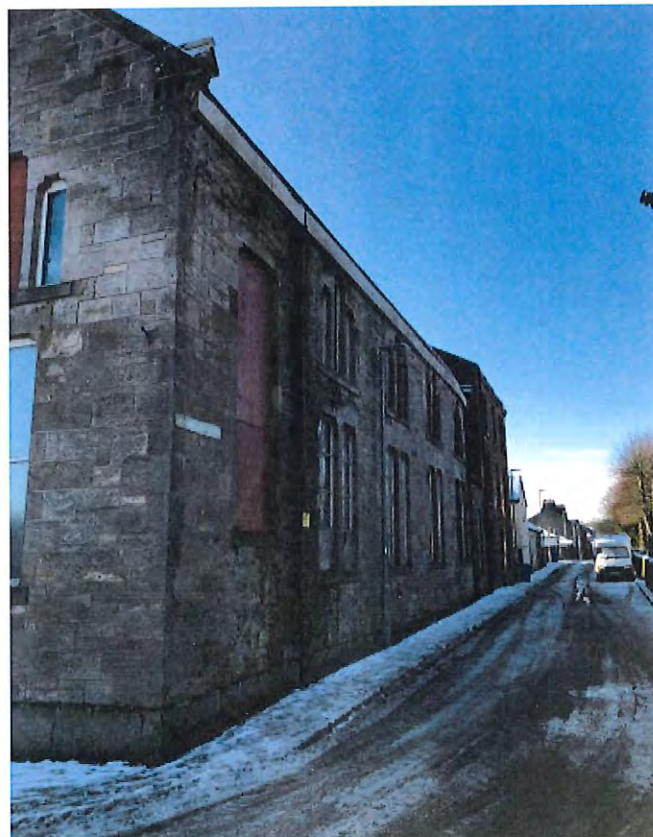
Side (Howard Street) elevation

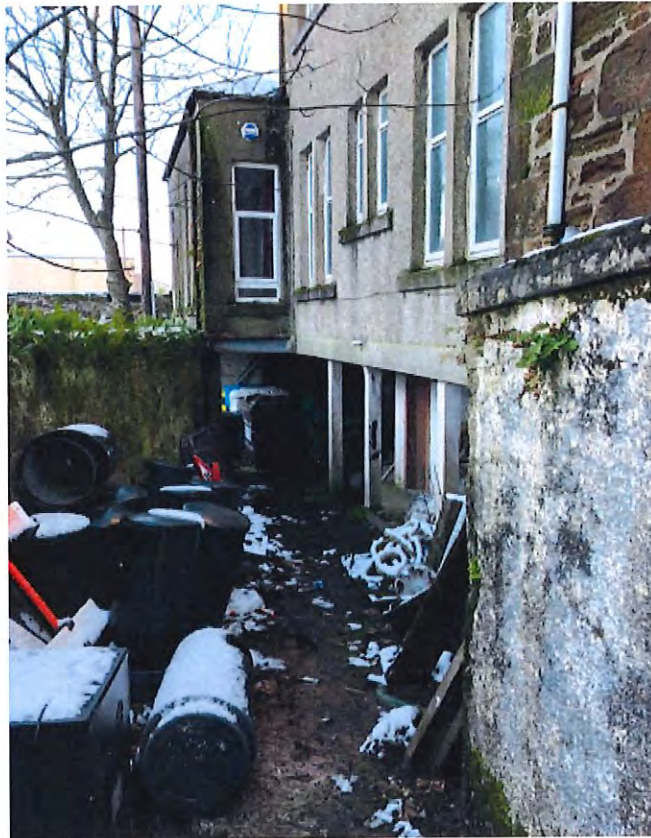
Southeast elevation (undercroft)

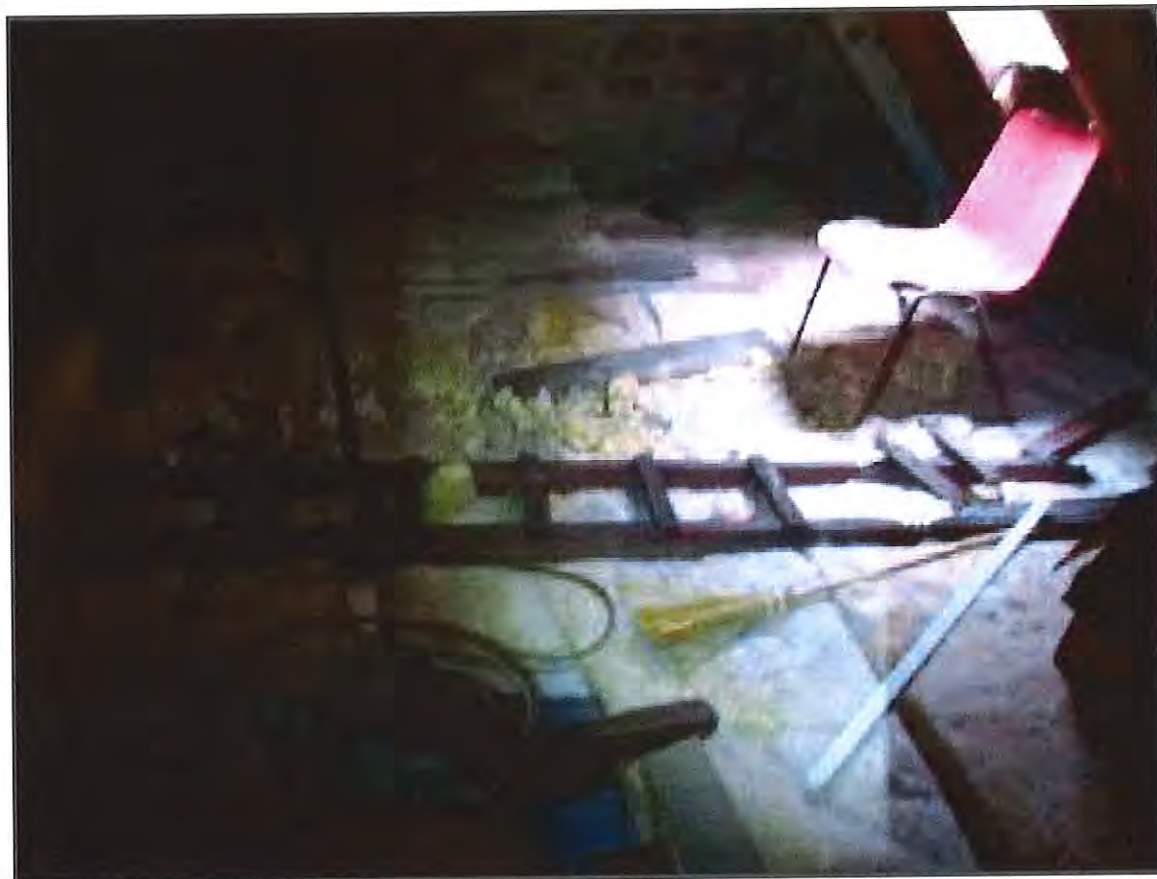
During the course of our visual inspection within the basement block it was noted that the construction of the ceiling/ground floor joists would appear to consist of an internal perimeter steel ring beam which is supporting the ground floor joists. The ground floor joists appear not to be built into the masonry where visually inspected.

Our inspection also revealed areas of water staining to the underside of the ground floor joists/T&G flooring where viewed from within the basement. Our inspection at ground floor level confirmed the presence of water lying on the top surfaces of floor coverings suggesting ingress from roof coverings.
